Geological Hazards in Samtskhe-Javakheti Region (Georgia)

Gaprindashvili George^{1,2}, Gerkeuli Tamaz¹, Tsereteli Emil^{1,2}, Gaprindashvili Merab¹

¹Department of Geology, National Environmental Agency, Ministry of Environment and Natural Resources Protection, Tbilisi, Georgia

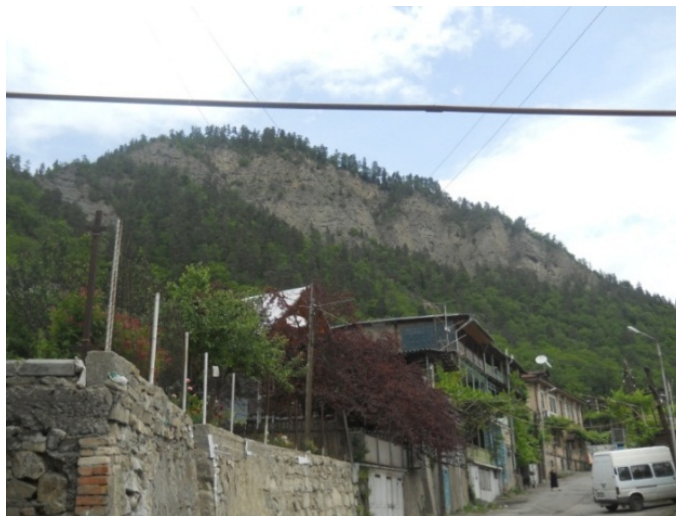
Borjomi city—still under the danger of rockfall are residential buildings which located at the foot of almost vertical cliff with height of 50 - 60 m, situated on the left bank of river Mtkvari (**Figure 6**). The exposition of cliff is southern-eastern, geologically it is represented by Paleogene-Early Eocene (BorjomiFlysch) marls, sandstones and tuffs. As a result of physical erosion of rocks, fall of materials with various sizes and also separate clods is taking place. 3 years ago, on the same street, 20-tonne clod fell and damaged residential building. In 50s of previous century, at the slope foot, for the purpose of population protecting, 200 - 220 m long trench was dug, in which crumbled materials were accumulated. This trench now is filled and lost its function. For the purpose of prevention it is necessary to clear the trench and periodically clear the slope.

Figure 6. City Borjomi, rockfall area.

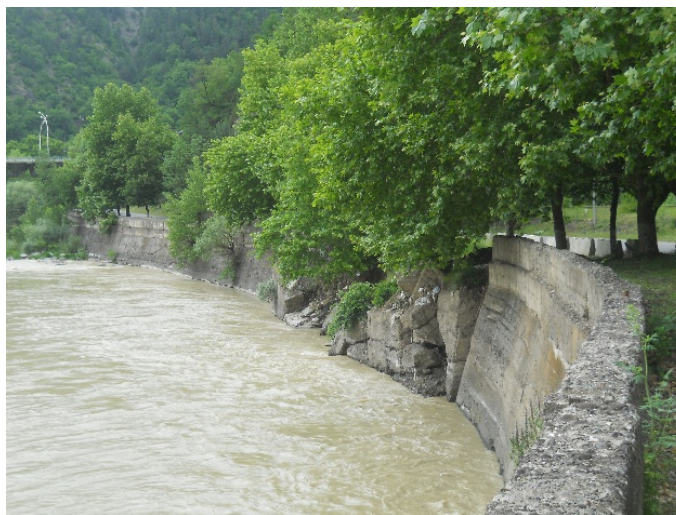
In the Orbeliani street sustaining walls of 12-13-10 and 15 m long, ruined and damaged in 2013, were restored. Sustaining wall of 25 m long, located on the right bank of river Mtkvari, should be restored (**Figure 7**).

Figure 7. Riv. Mtkvari right bank erosion.

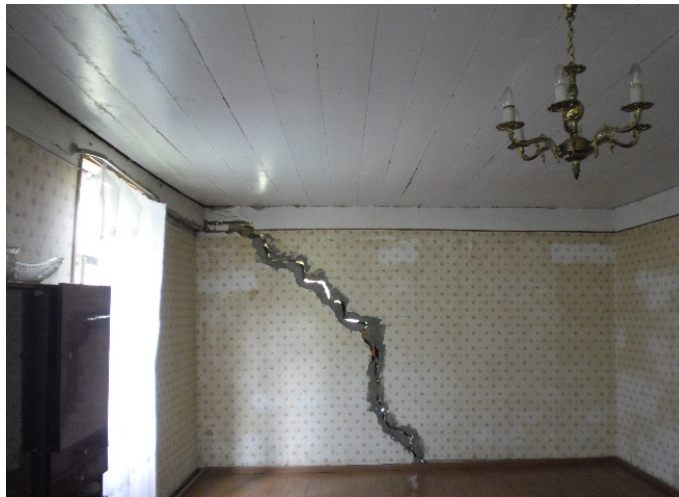
Village Dgvari—in this village landslide of modern generation is active. Its area is up to 300 ha. The landslide is plastic, creeping type. Its length is 2.0 km, width—1.5 km, thickness—15 - 20 m. In this village all buildings are damaged (**Figure 8**, **Figure 9**).

Figure 8. Village Dgvari, house damaged by landslide.

Figure 9. Village Dgvari, house damaged by landslide.

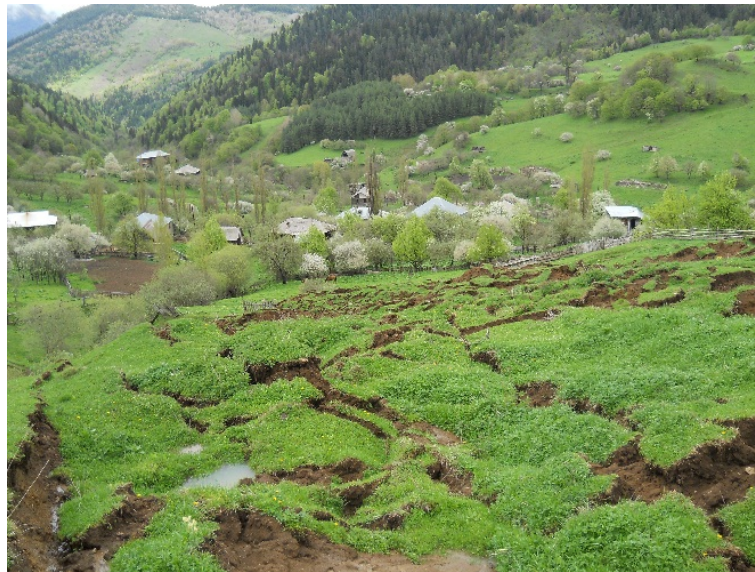
Village Didi Mitarbi. Landslide developed in the spring 2012 is in phase of temporary stability. It is sliding type, length is 120 m, width in the tongue part—60 m, average width—40 m. Area is 4500 m². Basis of this landslide are a homestead lands of local population at the foot of it. In previous year recommendation was issued for the purpose of process prevention which was not implemented. In case of activation 3 residential buildings at the foot of the slope will be endangered (**Figure 10, Figure 11**).

Figure 10. Village Didi Mitarbi landslide.

Figure 11. Village Didi Mitarbi landslide.

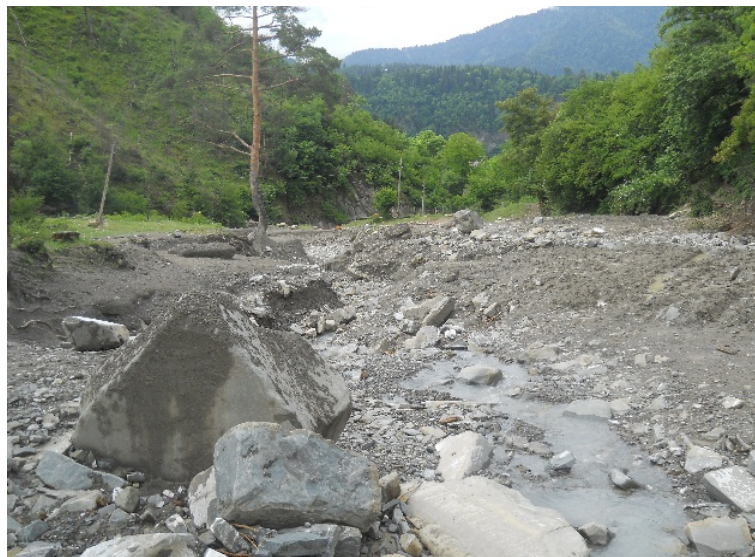
Debris flow broad gully of river Naghvarevi's water—in August 2008, as a result of Russian aggression, fire occurred on the territory of Borjomi municipality which damaged and completely destroyed woodland area up to 1000 ha. Intense erosion of slopes began. On the both slopes of broad gully landslide processes were developed. Almost all dry erosion broad gullies and ravines are able to form mudflows. On the bed of broad gully huge amount of terrigenous materials is accumulated (**Figure 12**) which is creating a danger to the population of village Daba. For the purpose of protection from debris flow/mudflows it is of urgent necessity to clear the bed of Naghvarevi broad gully so that in the period of next mudflows' proceeding which will inevitably happen village population should be protected from expected catastrophes.

Figure 12. Naghvarevis Tskali debris flow.

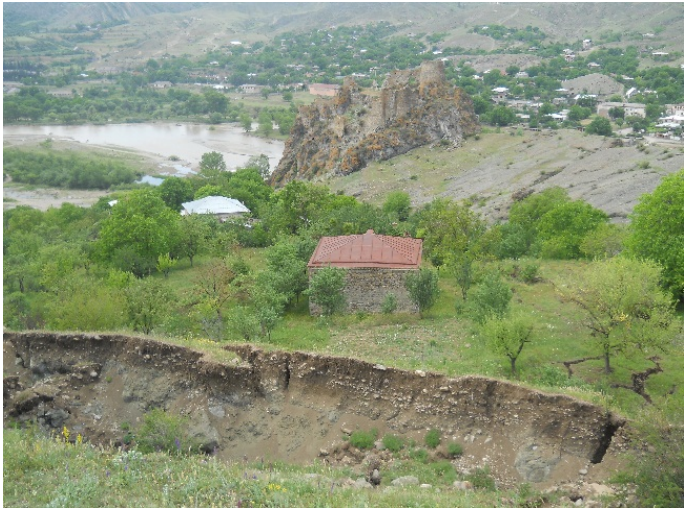
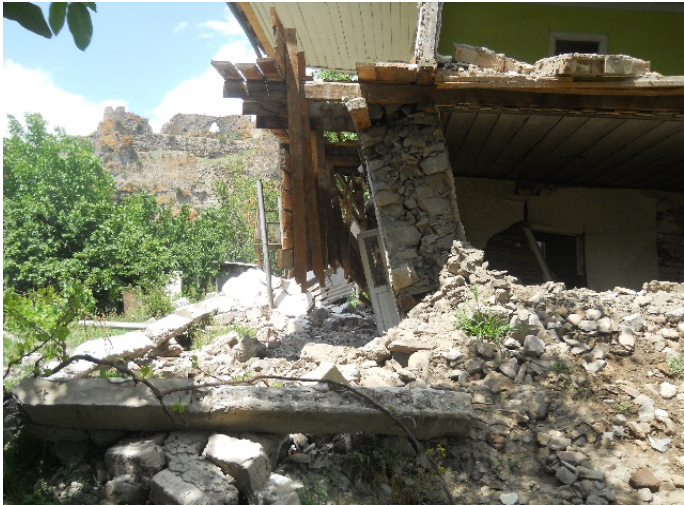
Village Gaghma Atskuri—landslide developed near the Atskhuri castle is still active (area—17.5 ha). This block type landslide developed during the earthquake of May 7, 2012. The length of landslide is 300 m, average width—up to 100 m, expected thickness—5 - 6 m. In the village 9 residential buildings are ruined, 12 households are under the high risk (**Figure 15**, **Figure 16**) [3] [4].

Figure 15. Village Gaghma-Atskuri landslide.

Figure 16. Village Gaghma-Atskuri landslide, destroyed house.

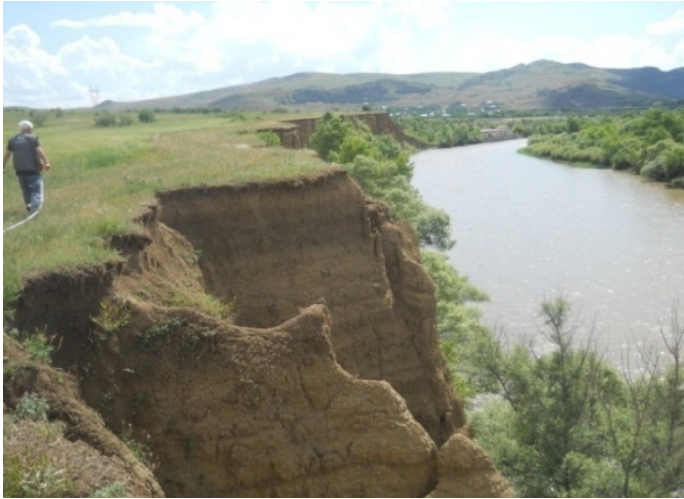
Village Thiseli—Landslide developed on the territory of this village is periodically active. Its area is 11.0 ha. This landslide during various occasions damaged 16 residential buildings, 7 buildings require repair which conditions might be worsened. In the Tkemlana-Sakuneti section on the bank of river Mtkvari is still alarming situation where intense erosion of bank is occurring on the length of 850 m (**Figure 17**) as a result of which vertical

Figure 17. Riverbank erosion (Tkemlana-Sakuneti section).

cliff of 15 - 18 m height is developed, and agricultural lands are eroded. For the purpose of prevention it is necessary to carry out coast-protecting works.

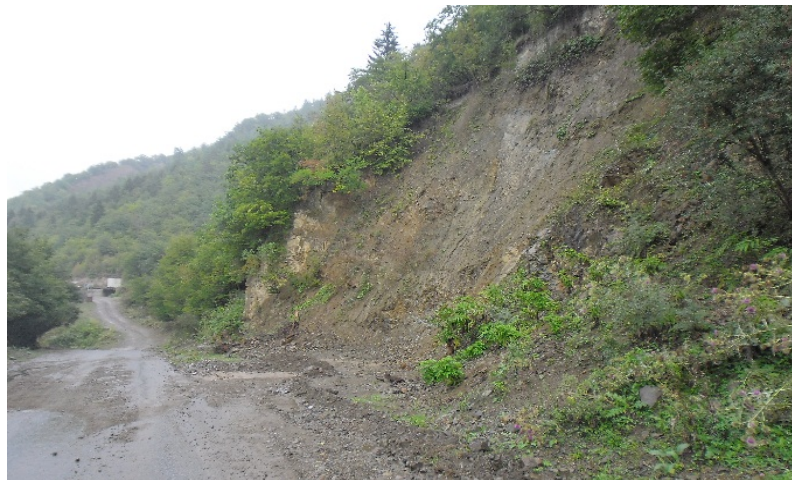
Near the village Chobiskhevi, in the spring of 2014, debris fall from the slope for several hours completely closed road on the length of 35 m (**Figure 18**).

Figure 18. Rockfall (Chobiskhevi road).

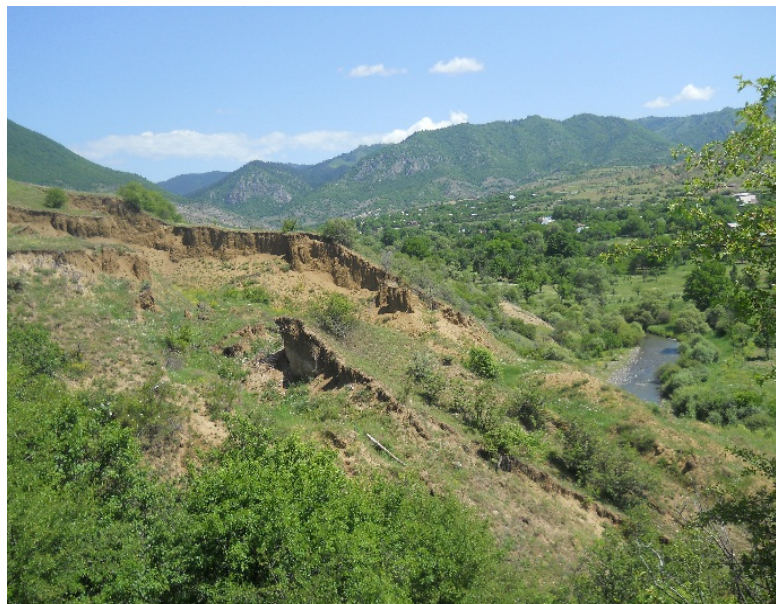
Village varkhani. Here regressive landslide developed on the right slope of river Otskhe is active. Its length along with valley is 130 m, width—from 80 to 120 m. On the slope early and newly created blocks are dumped (**Figure 19**) [6].

Figure 19. Varkhani landslide.
