# Installation of a Riparian Forest by Means of Soil Bio Engineering Techniques—Monitoring Results from a River Restoration Work in Southern Brazil

Soil bioengineering has been applied more and more in different regions of Brazil in recent years. The study in hand presents the installation of “new” riparian forest based on soil bioengineering techniques. This riverbank restoration work was implemented in the year 2010 and two onsite vegetation surveys, one shortly after the construction, and one in 2013. Besides that, the structures of reinforcement work, and its effectiveness were evaluated. By means of the vegetation survey, the applied species were examined for their ability to establish the riverbank in an environmentally sustainable way. Most notably, the species *Calliandra brevipes* Benth. (Fabaceae, Mimosoideae), *Phyllanthus sellowianus* Müller Arg. (Euphorbiaceae), *Salix humboldtiana* Willd. (Salicaceae), *Bauhinia forficata* Link (Leguminosae), *Inga marginata* Willd. (Mimosoideae) and *Ateleia glazioviana* Baill. (Leguminosae, Papilionoideae) showed a good growth development. The proportion of spontaneous vegetation increased significantly, with *Pennisetum purpureum*

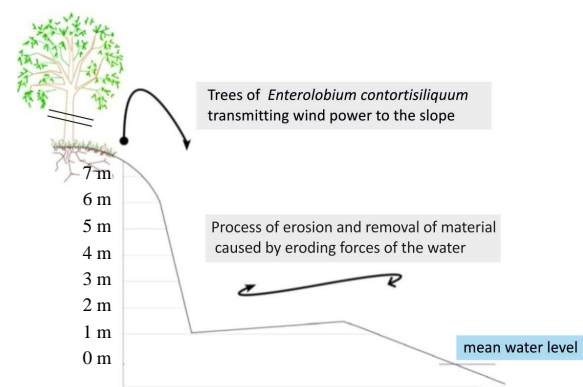
**Figure 2.**

The instability of the bank resulted from a continuous process of erosion, landslide, collapse and remove a lot material due to the action of the watercourse (see Figure 2).

The latter has shifted its axes outwards on this slightly curving river section. The instability of the embankment was exacerbated by the steep angle of the embankment, preventing the vegetation from spontaneous establishment. Additionally, the vegetation that was planted initially along the river at the top of the margin (trees of *Enterolobium contortisiliquum* (Vell.) Morong) did not have any stabilization effect on the site. Actually quite the reverse occurred. This vegetation formed an overhead

Sectional view, illustrating the eroding process.

in the vertical axes, shifting its center of gravity in a less stable position. It captures and transmits wind power to the slope, creating a lever that certainly amplifies the dynamics of landslides, triggered by the current of the stream (Durló & Sutili, 2005).

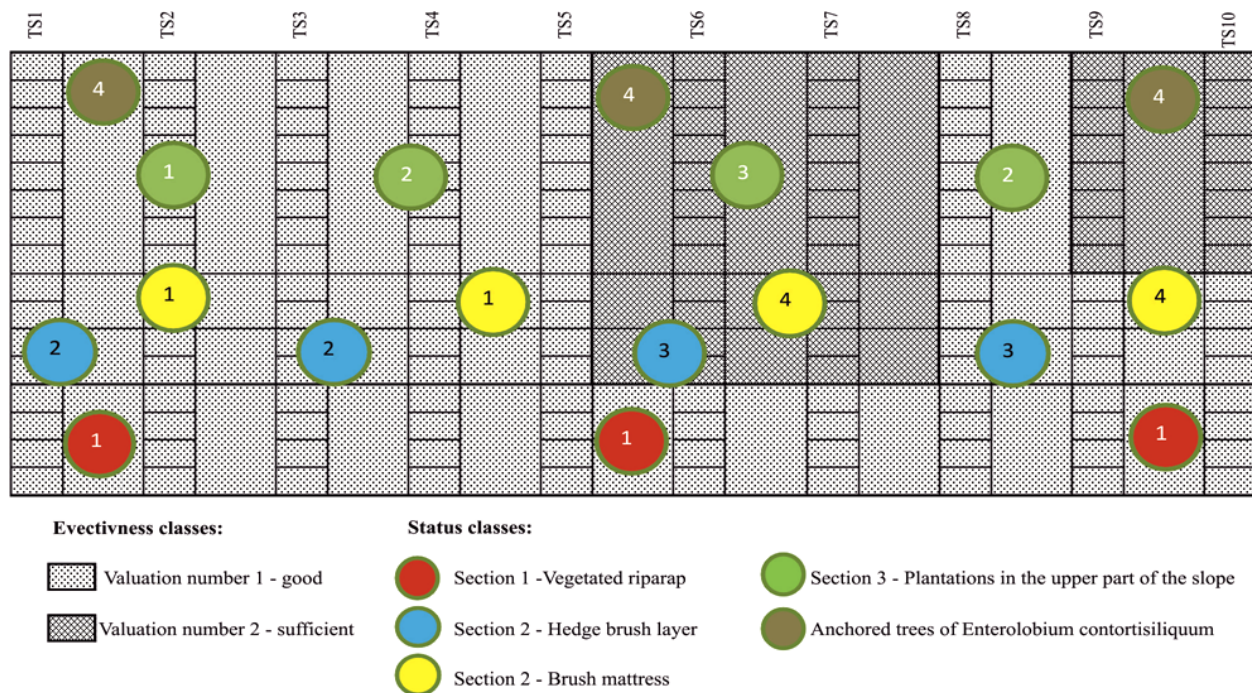
**Figure 7.**  
Evaluation of structures.

In Figure 6, the evaluation of the structures in terms of effectiveness and status is shown. As a whole, the intervention can be assessed as functional and safe. The effectiveness of the structures in conjunction with the present vegetation is rated in the classification classes 1 or 2. This means that the embankment is well protected and no imminent failure should be expected. Analyzing the structures separately showed some issues with the intervention. Only the vegetated riprap developed as it was supposed should have. In several spots, the implemented vegetation material did not or just sparsely emerge. Especially in the hedge brush layer and in the upper portion, where a wide range of species was fielded, the desired development was only partly achieved. The anchored willows showed a good development in half of the intervention, where high, vital brushes developed, making a major contribution to slope reinforce. In the other half, from transect 6 on, the brush mattresses could not develop at all. In the parts where the implemented vegetation did not develop as desired, spontaneous vegetation overtook the role of erosion protection, and therefore erosion just occurred point wise. Since the anchored trees of *Enterolobium contortisiliquum* were swept away shortly after planting, that intervention was classified with the category “destroyed”. Figure 7 shows the embankment before the restoration work in 2010 and after the monitoring in 2013.

Although slope reinforcement was obtained, the high proportion of spontaneous vegetation plus uncovered areas might endanger the stability in the long term. Implemented species which significantly diminished or disappeared completely are not recommendable for further slope reinforcement constructions. The **brush mattress** showed in half of the construction very good development and seems therefore to be an appropriate construction for the use in soil bioengineering works. However, in view of its large application along the whole construction, the assertiveness against other species seems to be relatively low due to the partial occurrence of *Salix humboldtiana*. This fact should be considered in further applications of brush mattresses using *Salix humboldtiana*. In the **upper part of the slope**, which is only prone to extreme flow conditions in case of flooding, the increase of spontaneous vegetation was partly very high and several fielded species could not develop as expected. This provides important information about the assertiveness of the species used. The sweeping away of the **anchored trees of *Enterolobium contortisiliquum*** might be a result of the one-sided anchoring to the slope. A double-sided anchoring might prevent floating in case of flooding.

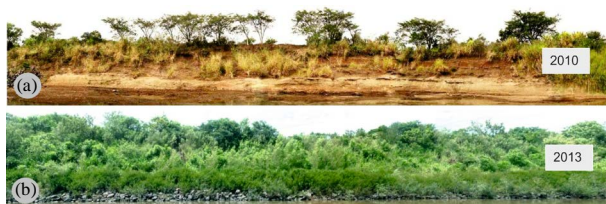
Figure 8 shows an overview of the situation before the intervention (2010) and after 3 years of plant development (2013). The “new” riparian forest based on the application of soil bioengineering techniques fulfills technical as well as ecological functions. The generated forest provides bank protection against erosion and creates new ecological habitats. Furthermore, the project shows that soil bioengineering techniques are

**Figure 8.** (a) Embankment before implementation of reinforcement works (Sutuli, 2010); and (b) two years after its completion (Hörbinger, 2013).
