A Defect Formation as Snail Trails in Photovoltaic Modules

Han-Chang Liu, Chung-Teng Huang, Wen-Kuei Lee, Shih-Siang Yan, Fu-Ming Lin

Green Energy and Environment Research Laboratories, Industrial Technology Research Institute,
Hsinchu, Taiwan
Email: itri960529@itri.org.tw

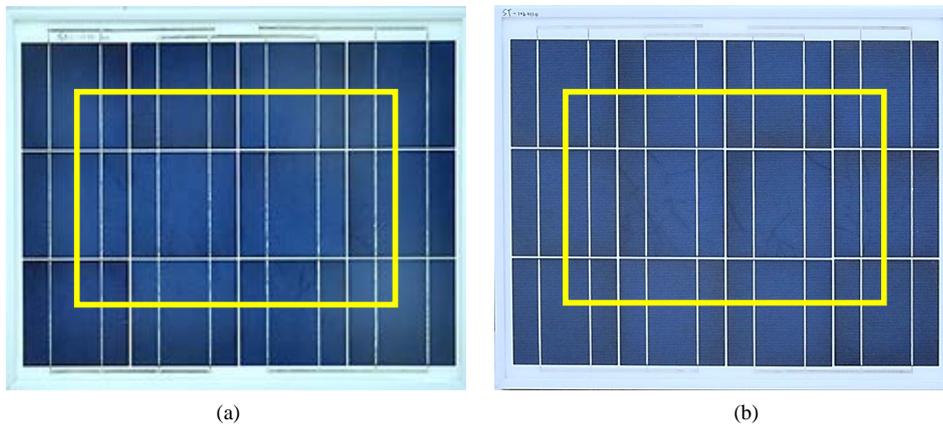
In this work we had successfully simulation the snail trails by our indoor method as shown in **Figure 1**. For risk analysis referring to snail trail effected modules it is not only to check power output, it is also essential to estimate to which extent further power degradation has to be expected within modules life time. These IV test results were shown in **Table 2**. In **Table 2** the initial powers represent the power loss after mechanical loading test with respect to cell cracks. Next sequence light soaking was performed on modules entitled of No. 1 - No. 4, after irradiance accumulation to $1120 \text{ kW}\cdot\text{h}/\text{m}^2$ the modules of No. 1 and No. 2 power loss was 3.61% and 2.26% without significant discolorations for snail trails, respectively, pictures here were not shown. However the modules of No. 3 and No. 4 which appeared the clear discolorations under glass front sheet as shown in **Figure 2(a)** and **Figure 2(b)** yellow squares, the power loss were 1.49% and 1.20%, respectively. This is a very interested to these testing results. We speculated the EVA encapsulant splaying important roles than backsheets to trigger the effect. These discolorations had different opinions in issued papers [1] [2] [6] [7]. In our former studying we had verified the EVA film Mvolume resistivity, which had less one order than EVA film S [8]. The poor electric resistances may promote Ag ions migration and formed electrochemical corrosion [7], hence caused the modules of No. 1 and No. 2 power loss more serious than modules of No. 3 and No. 4 without any discolorations. However inmodules of No. 3 and No. 4 power loss were not serious but appeared obvious snail trail discolorations. This may speculate to the EVA film S had extra antioxidant with respect to phosphorus [9], it plays a reductant to result the fingers discoloration like snail trails. In order to compare No. 4 module we also used the same encapsulation conditions entitled No. 5 module to perform outdoor exposed testing. These results showed in **Table 2** and **Figure 3(a)** and **Figure 3(b)** yellow squares. The No. 5 module had not only high power loss 16.84% but also snail trails. From these findings are suggesting additional power reducing processes not being correlated to the cell breakage but to electrochemical corrosion. The outdoor environment combined with high temperature and high humidity accelerated the Ag fingers corrosion to cause the No. 5 module power loss seriously. In **Figure 3(b)**, the electroluminescence (EL) images showed the micro cracks which corresponding to snail trails formation. The snail trails following with cracks that induced a lot of moisture into module from back side and accelerated Ag ions migration to cause cell fingers discoloration and corrosion. In our studying the slight crack not caused power loss but serious cell cracks can cause the power loss seriously and more snail trails to be appearance.

Figure 2. Photographs of modules with snail trails (a) No. 3 and (b) No. 4 module.

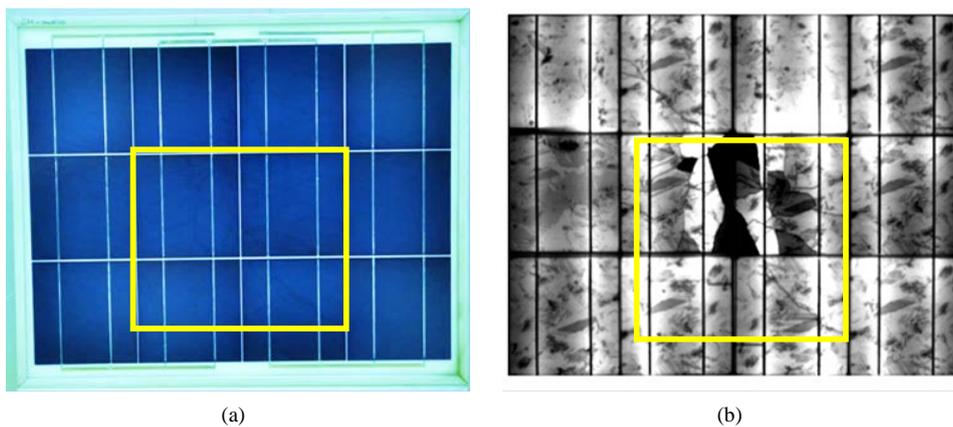
Figure 3. The correlation between (a) Visible optical features (snail trails) and (b) Micro cracks visible in EL imaging after No. 5 module outdoor exposed testing.

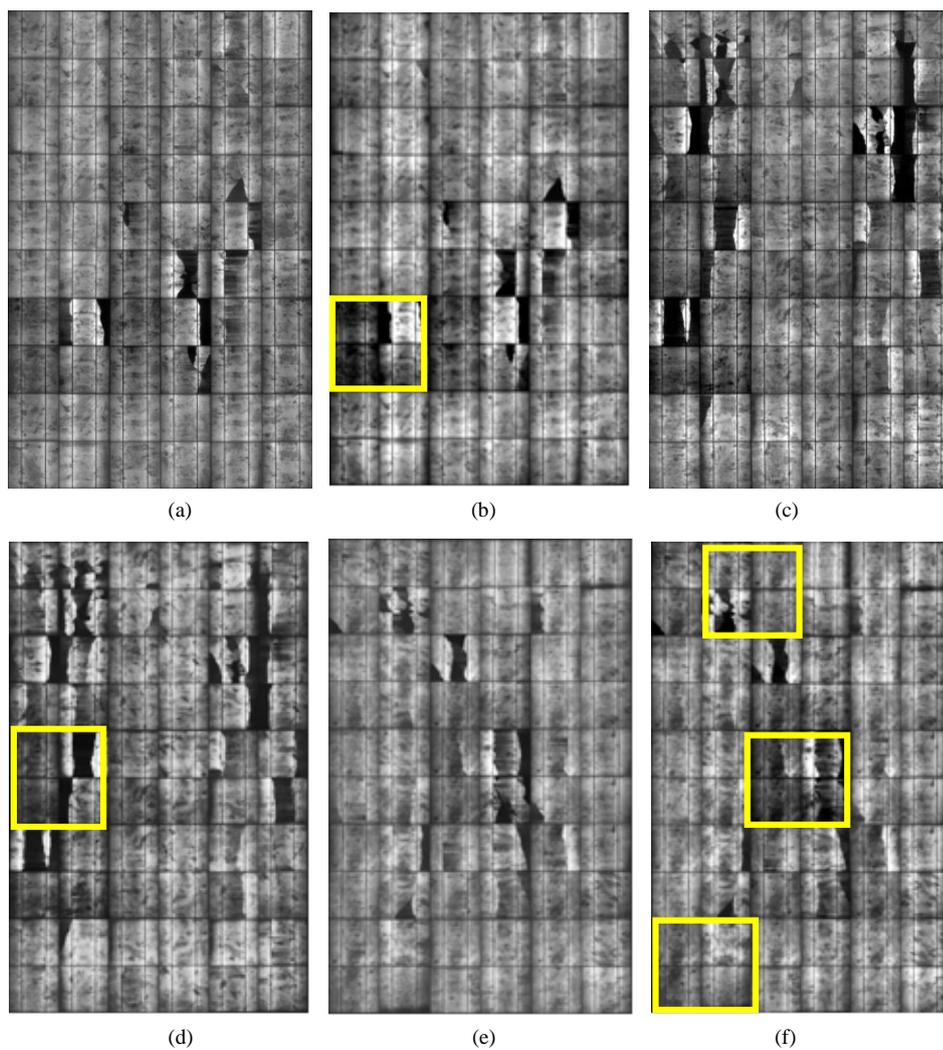
Figure 4. Comparison of snail trails in field with EL images before and after accelerated aging tests (a) before TC200, (b) after TC200, (c) before HF 10, (d) after HF 10, (e) before DH1000 and (f) after DH1000.

tests were 8.38%, 11.36% and 9.54%, respectively. All snail trail modules decreased power within 2% during testing period and no discolored areas enlarged by our visual inspection. In here we can speculate the reactants such as EVA excessive antioxidant or peroxide exhausted and no further discoloration. A special phenomenon was observation in our long term 3000 hours damp heat test which original snail trails were disappearance (pictures here not shown) it like reversed process [10]. In **Figure 4** the EL images showed cells micro cracks did not enlarge and no new micro defects were formed in the PV modules during the accelerated aging tests. From EL images showed little darken at former crack areas after these tests as shown in **Figure 4(b)**, **Figure 4(d)** and **Figure 4(f)** yellow squares. There were corrosion formations to increase series resistance. In our results showed the power loss not serious after these accelerated aging tests. But not warranty the module performance correlated with cell cracks in the future. The cell cracks defects would need to be checked more detail to assure the PV module lifetime in future 25 years.
