Inspection and Assessment of Highway Bridges in Jordan along the Desert Highway: A Case Study

Hamadallah Al-Baijat, Mohammad Alhawamdeh

2.1. Al-Qadisia Bridge (Pre-Stressed and Reinforced Concrete Bridge)

2.2. Unayza-Petra Bridge (Reinforced Concrete Bridge)

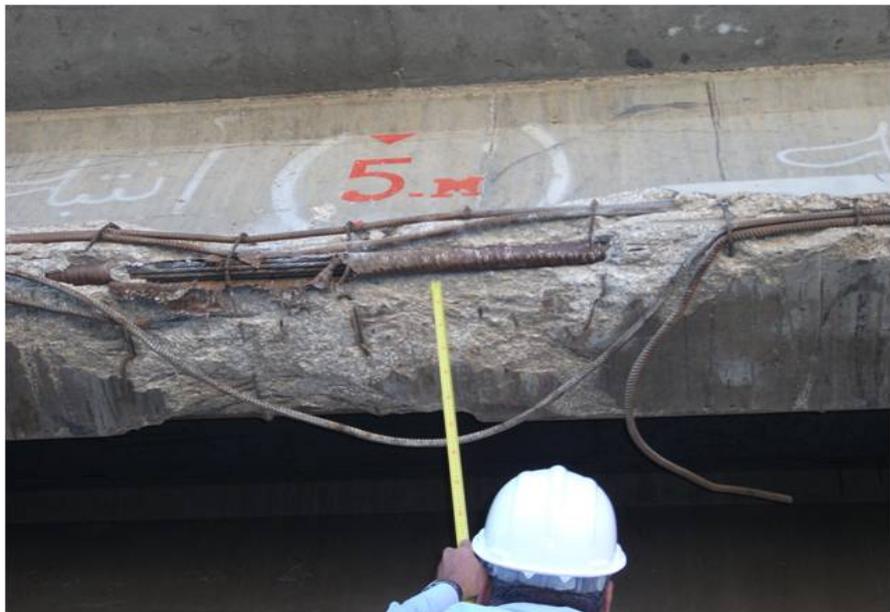
Figure 3. Deterioration at the bottom of web of Girder No.10: sever damage in longitudinal steel reinforcement, cutting of stirrups, full concrete cover spalling, enter removal of pre-stressed duct, and heavy deterioration of strands.

3) According to the current inspection, Girders No. 1, 2 on the eastern direction and No. 10 on the western direction need immediate replacement because of severe damage (the inspectors concluded that it will be less expensive than repairing and rehabilitating them by 19.6%). However this technique needs highly qualified people and high quality materials with past experience in this field.

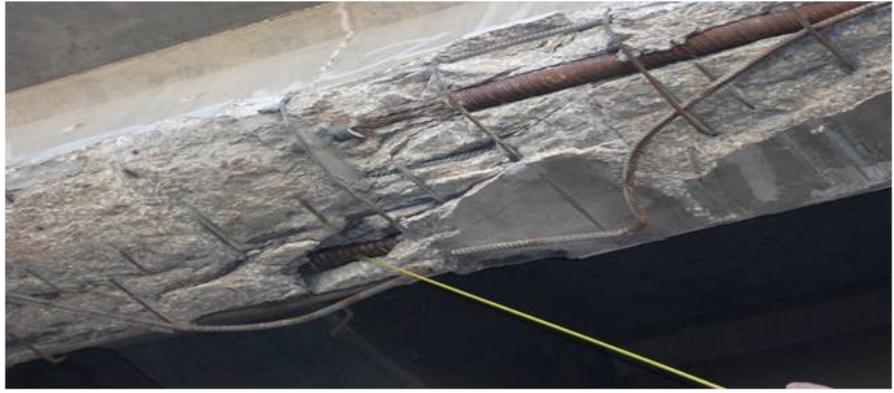
Figure 4. Deterioration at the bottom of web of Girder No. 7: moderate deterioration of Strands and longitudinal main steel, and cutting of stirrups and concrete spalling, also extensive concrete cracks.

4) Girders No. 4, 5, 6, 7 on both western and eastern sides need immediate rehabilitations.

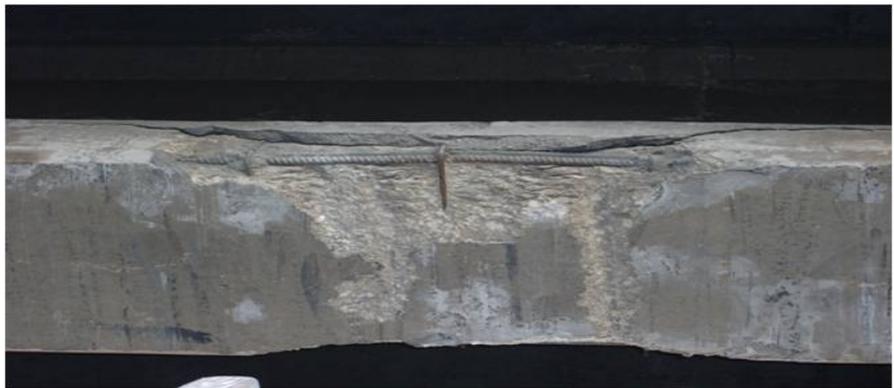
Figure 5. Girder No. 6 moderate deterioration: concrete spalling, displacement of main steel and deep cracks.

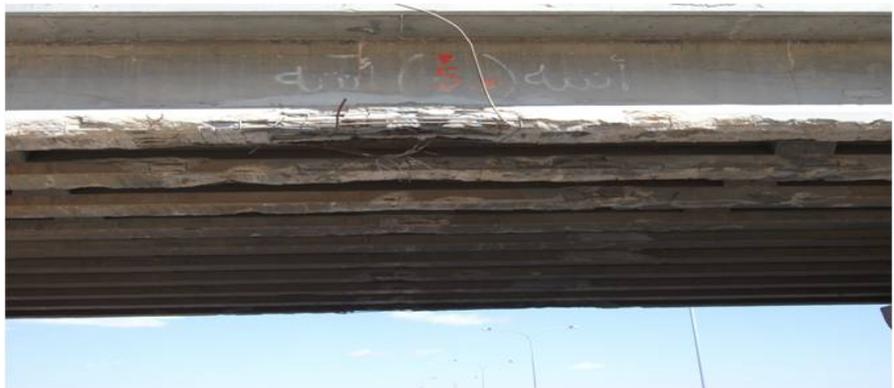
Figure 6. Sever deterioration of concrete at Girder No. 1: entire removal of concrete cover, deep cracks on the web reaching the flange, Strands cutting, main steel reinforcements and stirrups cutting.

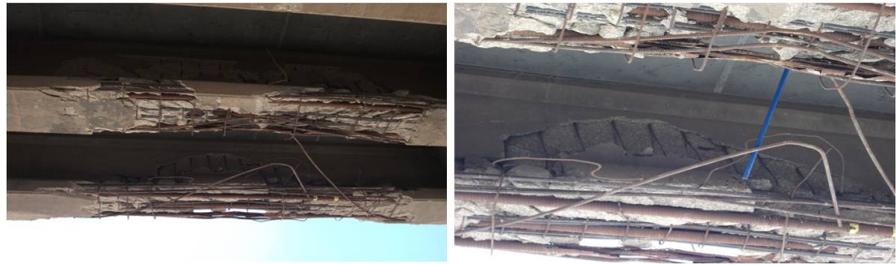
Figure 7. Very heavy deterioration on Girders No. 1 and 2: entire concrete spalling, heavy deterioration and cutting of strands, deep cracks along the web reaching the flange, displacement and cutting of longitudinal reinforced Bars and Stirrups.

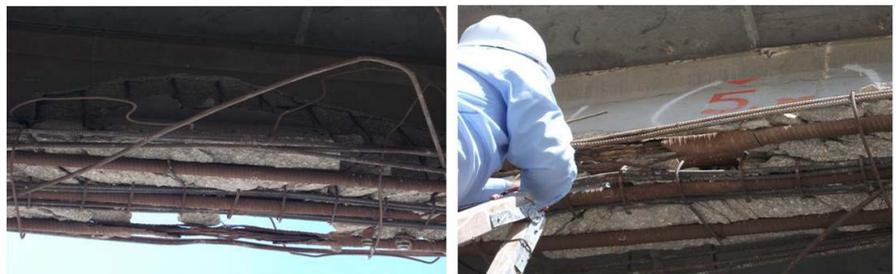
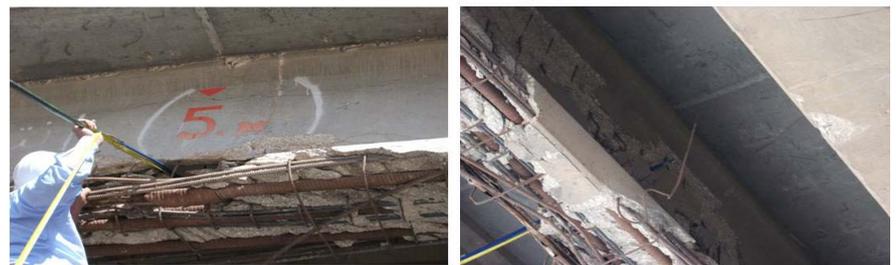
Figure 8. Close sight on Girder No. 1: (a), (b) Entire removal of concrete, deep cracks, also steel reinforcements, stirrups, and strands cutting. (c), (d) Complete isolation of the bottom flange from the web (Complete Failure).

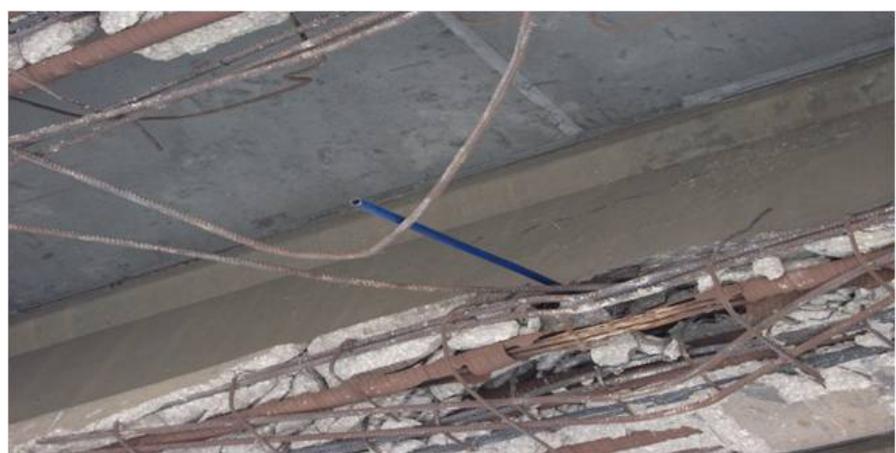
Figure 9. Deterioration of Girder No. 2: cutting of steel bars, severe removal and cracks of Concrete, and heavy deterioration of Strands.

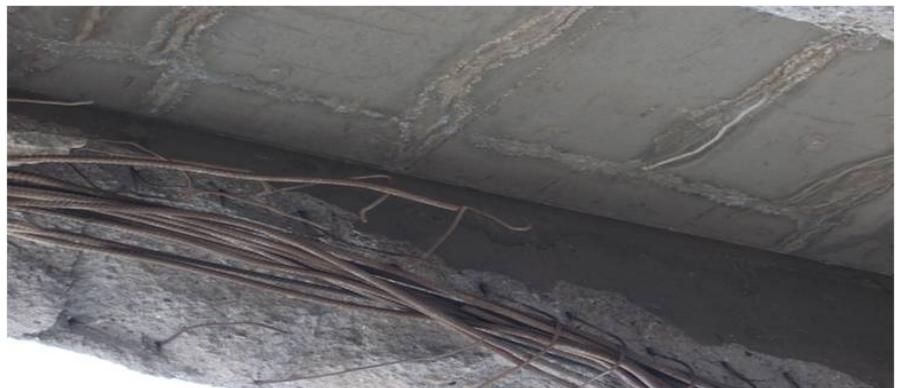
- Concrete girders damage caused by over-height vehicle collision as shown in **Figure 12** and **Figure 13**.
- Insufficient clearance.

Figure 12. Deterioration of Girder No. 1: entire spalling of concrete, heavy damage of the girder steel reinforcement, and cutting of stirrups.

2) According to the current inspection, Girder No. 1 on the western direction needs immediate replacement because of severe damage (the inspectors concluded that it will be less expensive than repairing and rehabilitating them by 27.1%).

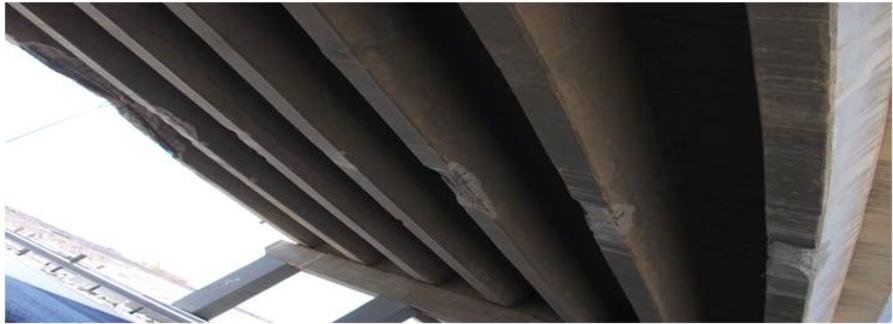
Figure 13. The deterioration of Unayza-Petra Bridge girders due to collision with over-height trucks.

1) It is necessary to have clearance of 5.6 m as a minimum height to avoid collision with over-height trucks. This needs a topography surveying to achieve this task.

3) Girders 2, 3, and 7 on the eastern direction need immediate repair and rehabilitation.
