A Study on the Cause Analysis for the Wall Thinning and Leakage in Small Bore Piping Downstream of Orifice

Kyeong Mo Hwang, Chan Kyo Lee, Cheong Ryul Choi
Power Engineering Research Institute, KEPCO-E&C, Yongin, South Korea
Email: hkm@kepco-enc.com

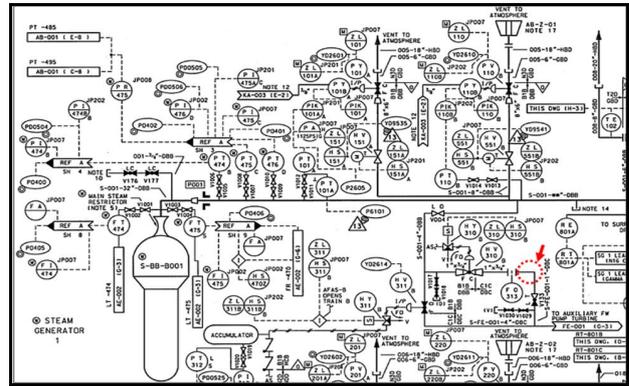
Figure 1. Leak point on P & ID.

The leaked 1 inch pipe was designed to serve extraction steam during abnormal or emergency operation from the main steam line to the auxiliary feedwater pump turbine. During normal operation, the extracted steam goes to condenser through the pipe. Dotted circle in **Figure 1** shows the leaked point, which is right behind orifice plate. A control valve is placed on in front of the orifice. The design and operating conditions for this line are as follows:

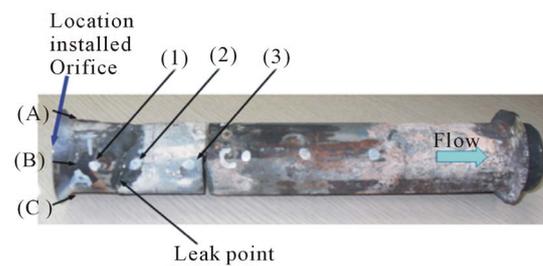
Figure 2. UT inspection and leak points.

In total, 24 pipe thickness measurement data were obtained in the laboratory. Equally spaced 6 points were marked around the circumference at 2 cm intervals along the length of the pipe. The thickness measurement is conducted using UT measuring device. As presented in **Table 1**, point (2B), adjacent area to orifice, has the minimum thickness 0.94 mm. The point is located in the bottom side of the pipe. Behind circumference point 4, thinning is not found as all thickness data have more than nominal thickness 4.547 mm. The leak-occurred point is between longitudinal points 1 and 2 and between circumference points A and B. The crack size is about 2 cm. **Figure 2** shows the UT inspection points and leak occurred point on the component.

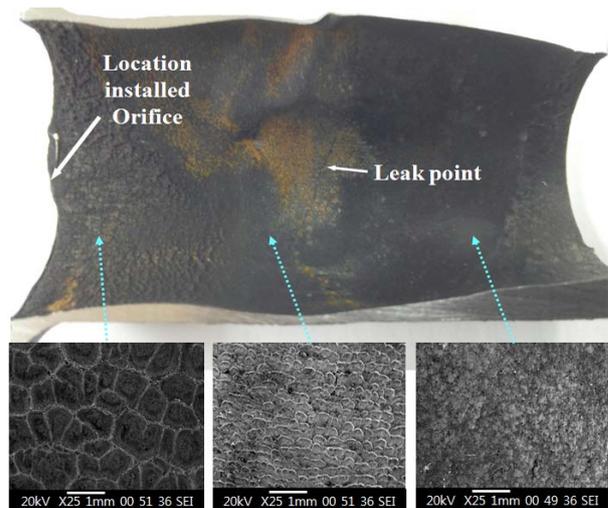
Figure 3. Optical and SEM pictures of leaked pipe.

Optical and SEM images are used to observe the damaged surface. **Figure 3** shows the inner surface of the axially sectioned pipe by optical image and close surface images by SEM. Adjacent area to the orifice has significantly worn-out surface in optical image. The leaked area has smooth surface in optical image, yet tiny craters are found in SEM images. Damage is hardly found in the downstream area of the pipe. Most wears are found close to the orifice, in which significantly worn-out surface is found as well, although leak has not occurred in the area. It is highly probable that the welding bead between the orifice and the pipe is considerably thick.

As shown in Figures 15-17, it is found around leak occurred (A2) that the larger droplet size has, the bigger droplet impulse has. As shown in the Figure 3, erosion occurred most frequently immediate behind the orifice.

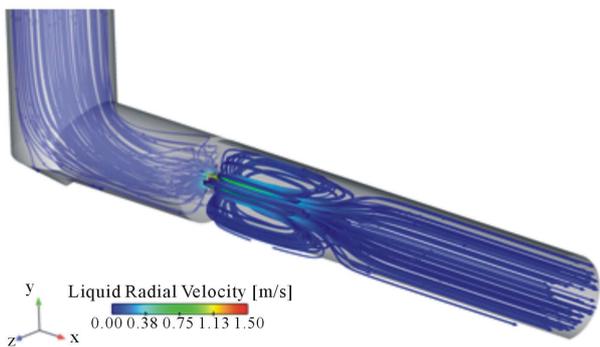
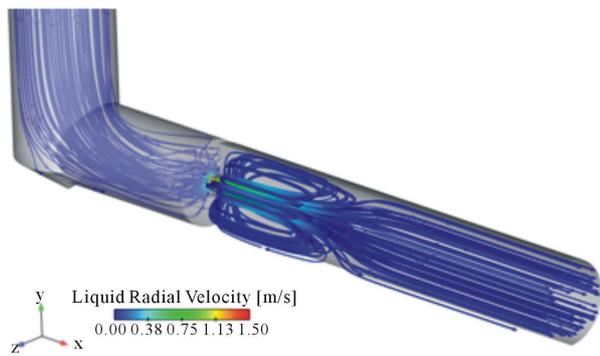
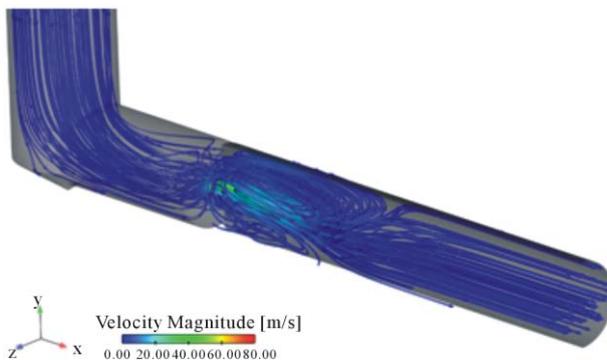
Figures 6-8 show the liquid droplet stream lines for droplet sizes of $1 \mu\text{m}$, $10 \mu\text{m}$, and $20 \mu\text{m}$. Stream lines are similar for droplet size $1 \mu\text{m}$ and $10 \mu\text{m}$. Flow coming from the orifice shows high speed jet behavior. Recirculation zone is formed around the high speed jet area. As the flow goes downstream farther from the orifice, the width of the steam jet is gradually broadened, and the intensity of the steam jet is gradually weakened. Flow reattachment point appears approximately $2D$ downstream from the orifice. Unlike the cases of droplet sizes of $1 \mu\text{m}$ and $10 \mu\text{m}$, a great vortex flow is generated for the case of droplet size of $20 \mu\text{m}$ in the upstream area of the pipe, and a relatively small vortex flow is generated in the downstream area of the pipe. It is highly probable that a vertical flow path in the valve and grown inertia force by the large droplet size make the flow run diffe-

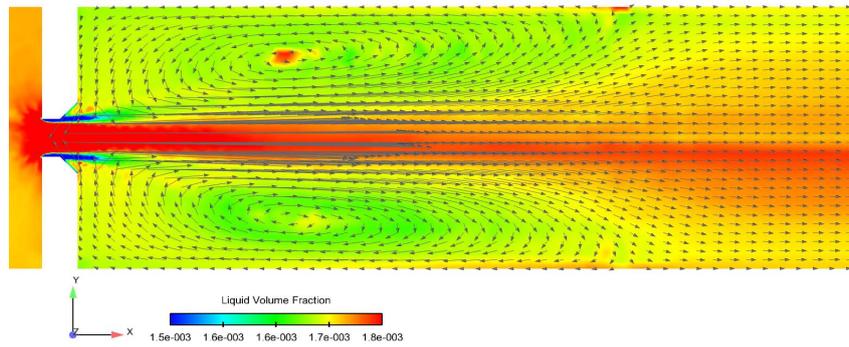
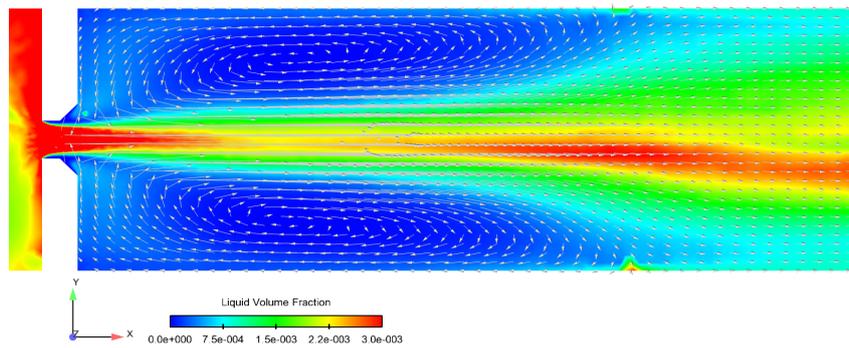
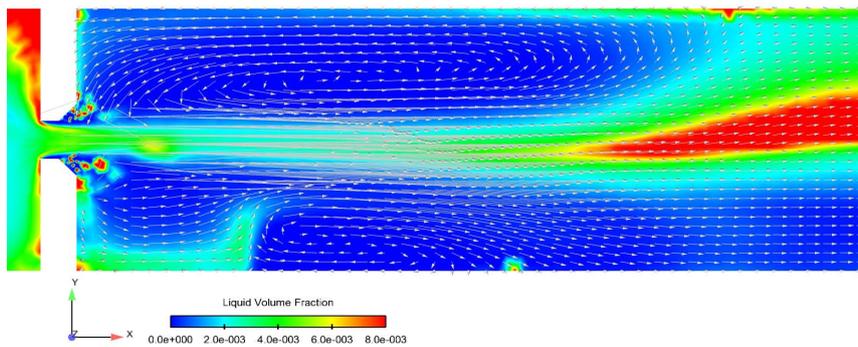
Figures 12-14 show the liquid droplet volume fractions with their velocity vector for droplet sizes of 1 μm , 10 μm , and 20 μm . For droplet size at 1 μm , it is seen that droplets disperse approximately 2D downstream from the orifice. As the droplet size grows larger, droplets have tendency to go straight forward from the orifice. For droplet size of 20 μm , droplets have tendency to go upwards approximately 2D downstream from the orifice.

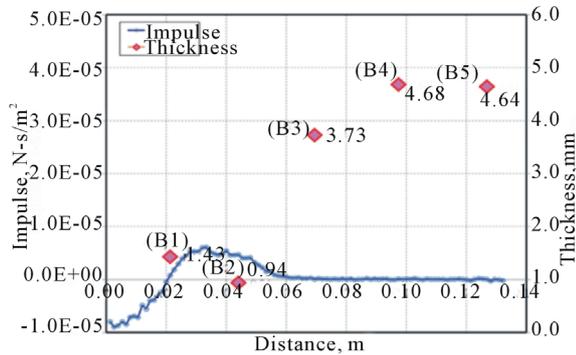
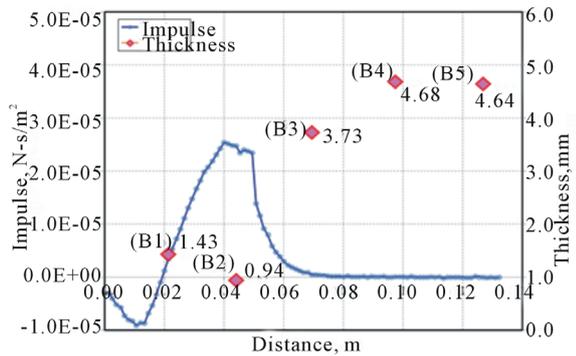
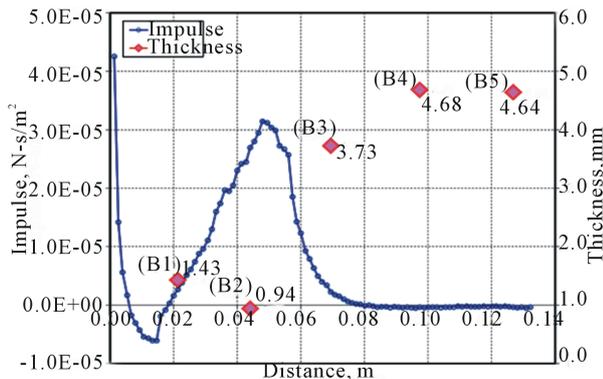
It is known that liquid droplet impingement erosion rate is proportional to 3.6 to 5.2 power of droplet velocity [1,5,6]. Using droplet density distribution and radial velocity, droplet impulse can be calculated along the length of the downstream pipe behind orifice. The impulse is calculated at 95% diameter area from the pipe center. This is because droplet velocity on the wall is 0 m/s. Figures 15-17 show the comparison between the impulse and the thickness data along the length of the pipe for droplet sizes of 1 μm , 10 μm and 20 μm . The thickness data are acquired from the area underneath the leak occurred in the pipe. The lowest thickness data is measured from area around the leak occurred (A2).

Yet, thickness measurement cannot be conducted due to welding bead. Those things are represented in Figure 17. The impulse right behind orifice end, where the orifice is installed, is larger than the impulse in approximately 0.04 m distance from the orifice.
