Testing of Decision Making Tools for Village Land Use Planning and Natural Resources Management in Kilimanjaro Region

Anthony Z. Sangeda^{1*}, Frederick C. Kahimba¹, Reuben A. L. Kashaga¹, Ernest Semu¹,
Christopher P. Mahonge¹, Francis X. Mkanda²

¹Sokoine University of Agriculture, Morogoro, Tanzania

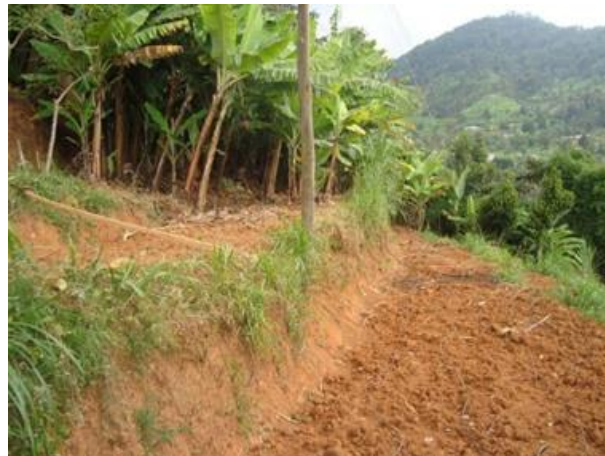
Figure 3. Terraces with elephant grass in the uplands of Kili-manjaro Region.

The climatic conditions of the eastern part districts were mainly modified by the presence of the Pare mountain ranges, characterized by low rainfalls especially in the lowlands (<400 mm) along the Pangani River areas. The central and western part climate was modified by the ecology of the Kilimanjaro Mountain, making it much cooler, covered with clouds most of the time, and experiencing higher rainfalls. Considering the topo-sequence, all the districts were divided into highlands, midlands, and lowland areas (**Figure 2(a)** and **Figure 2(b)**). The upland areas were characterized by permanent crop plantations, forest reserves, and steep slopes, some with soil conservation measures such as bench terraces (**Figure 3**), and higher population density in settlement areas.

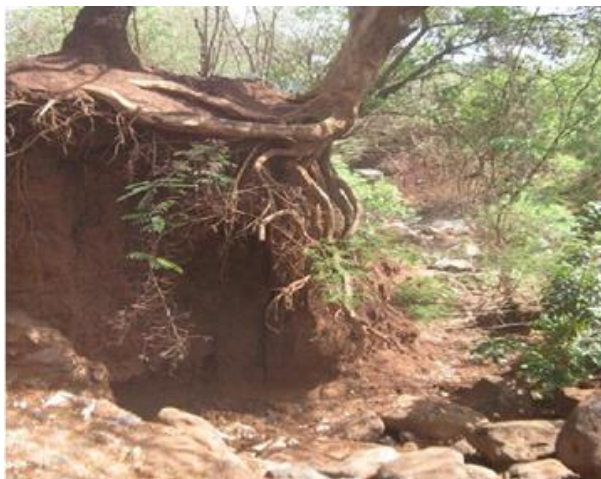
Figure 4. Land degradation in the lowlands of Kilimanjaro Region.

Gully erosion was not profound in this zone due to lesser accumulation of stream flows and existence of good forest cover as opposed to midlands and lowlands (**Figure 4**). However, the paradigm shift from perennial coffee plantations to maize farming has resulted in removal of tree sheds in the fields to create favorable environment for annual crops such as maize. This shift has caused most of the land in the uplands and midlands to remain bare during dry season as crop residues are harvested for animal feeds as it can be depicted in the temporal land use change maps (**Figure 2(a)** and **Figure 2(b)**).

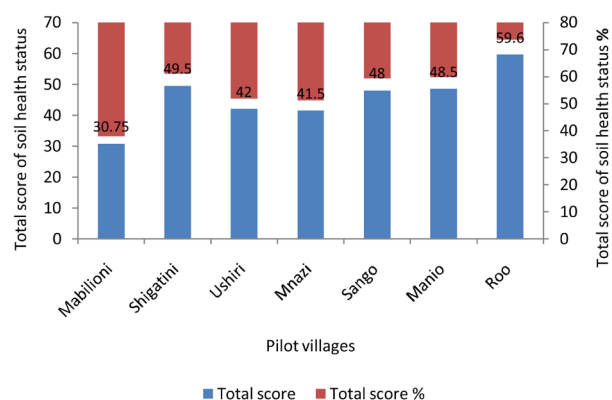
Figure 5 shows differences in the soil health status of the different villages. Mabilioni village was lowest in ranking and Roo was highest. The health parameters that contributed most to the lower scores were, macrolife diversity, earthworms, and ground cover (**Table 3**). Other parameters gave somewhat average scores for many villages, with Roo village showing overall higher scores. Soil physical properties (ease of penetration, ease of infiltration, soil structure, root development and aggregate stability) were generally medium to high for most villages. Plant colour/size, as proxy for chemical soil fertility was high for Roo, Mnazi and Shigatini villages. The abnormal colours that were widely mentioned as occurring on crops, thus contributing to low soil health scores, were yellowish/pale green and purple colours, implying low levels of nitrogen and phosphorus, in the soils respectively. Generally, Mabilioni village soils were of poor health while Roo village had good health soils. All other villages had soils of medium health.

Figure 5. Soil health status in the pilot villages as captured by soil health assessment tool. Key: low = 0% - 33 %; medium = above 33% - 66%; high = above 66% - 100%.

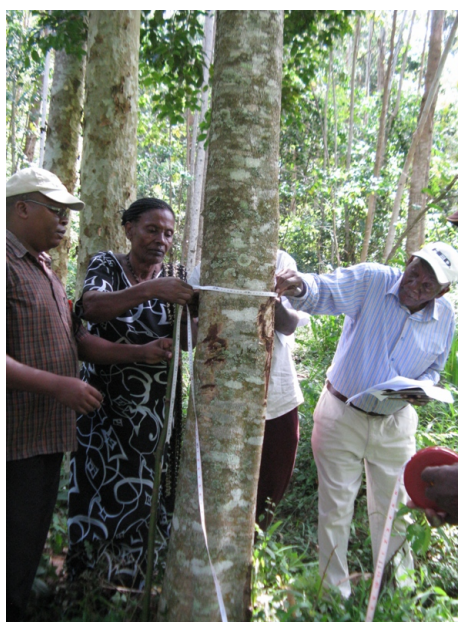
Figure 6. Participatory carbon assessment by communities in Shigatini Village, Mwangi District in Kilimanjaro Region, Tanzania.

The assessment involved hands-on exercises done by communities themselves. After explanation and demonstration on how to demarcate plots and how to take measurements, tools were given to a group of communities and they were asked to undertake the exercise by themselves. The trainers were around to assist communities where they went wrong. Some of group members were taking measurements and some recording the data. Important instrument that was fabricated locally for use was the 1.3 m stick, which was used to determine the height where the diameter at breast height (DBH) measurement was to be taken. The rest of the tools were the ones that could easily be bought in village shops.
