Corrosion Study of AISI 304, AISI 321 and AISI 430 Stainless Steels in a Tar Sand Digester

ABSTRACT

This work has investigated the corrosion properties of three types of stainless steels in a tar sand digester environment with the aim of establishing their relative resistances in the environment. The corrosion experiments for the stainless steels were conducted by the non-electrochemical immersion technique with corrosion rates expressed in mils per year (mpy). The spectroscopy analysis of the Nigerian tar sand was done by the energy dispersive x-ray analysis. The surface study of the corroded stainless steels was accomplished via a scanning electron microscopy (SEM) to reveal the form of corrosion.

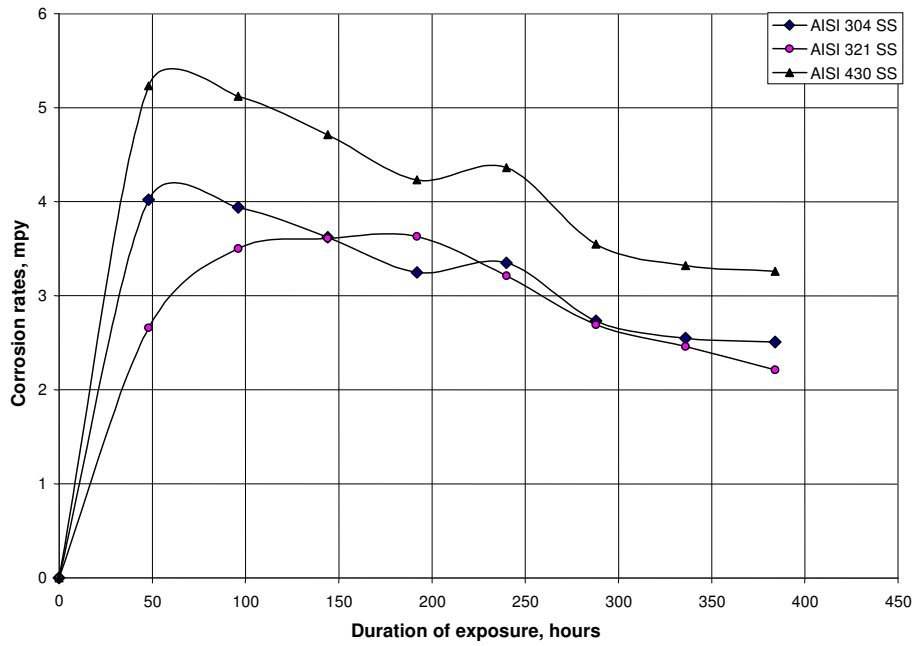
Fig. 1. Corrosion of types AISI 430, AISI 304 and AISI 321 stainless steels in a tar sand digester

Figure 1 depicts the corrosion behaviour of the three different stainless steels investigated in this study. From this figure the austenitic grades of stainless steels: AISI 321 SS and 304 SS show better corrosion resistance behaviour in the environment than the ferritic grade (AISI 430 SS) considered. Comparing the two austenitic grades, the stabilized AISI 321 SS showed better corrosion resistance than AISI 304 SS. This is probably because the 321 grade contains about 0.60% Ti in addition to increased nickel content of the steel (10.37Ni) in comparison with the AISI304 grade (that contains only 8.54Ni).

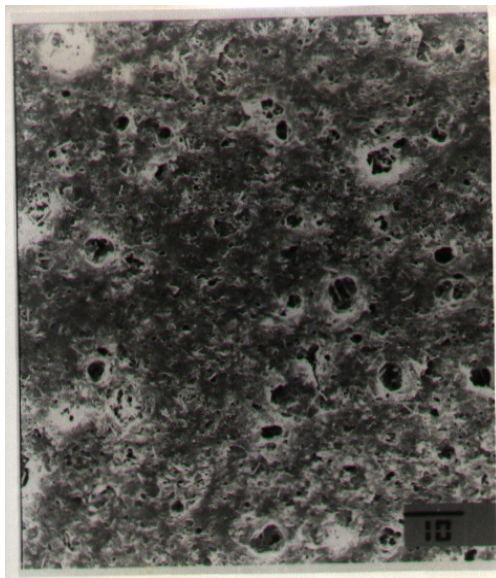
Fig.2 Scanning electron micrograph of a corroded AISI 430 SS after 20 days of exposure x 1000

The micrographs in Figs. 2 to 5 of the corroded stainless steel samples after twenty days of immersion showed a greater tendency to pitting or crevice corrosion by the 430 grades than the austenitic grades. The micrograph of Fig. 2 is of the corroded surface of the AISI 430 stainless steel. The micrograph shows features that resemble wide spread of pits all over the surface. Fig. 3 is a better resolution of the corroded surface of the AISI 430 SS. It shows that some of these pits because of their depths probably started as crevice corrosion under a tar sand deposit that stuck to the surface of the samples. It is also being suspected that some of the pits probably arose from the pitting corrosion around inclusions in the matrix of the stainless steel and some from the presence of some elements in the Nigerian tar rich sand as will be explained later. Figs. 4 and 5 show the corroded surfaces of the 304 and the 321 stainless steels respectively. In both of them the tendency for pitting and crevice corrossions is remote. In general, our observations also showed partial removal of chromia film (Cr_2O_3) on the surface of the austenitic grades. According to the literature (Oluwole et al, 1980 and Ukwuoma and Ademodi, 1999) some of the

That is, the metal ion deposition is a possible cathodic reaction in tar sand corrosion reactions. As a result of the localization of these reactions on the surface of the steels we have some pockets of pits on the corroded surface as evidenced in the SEM micrographs of Figs. 2 and 3 due to the ferritic AISI430 stainless steel.

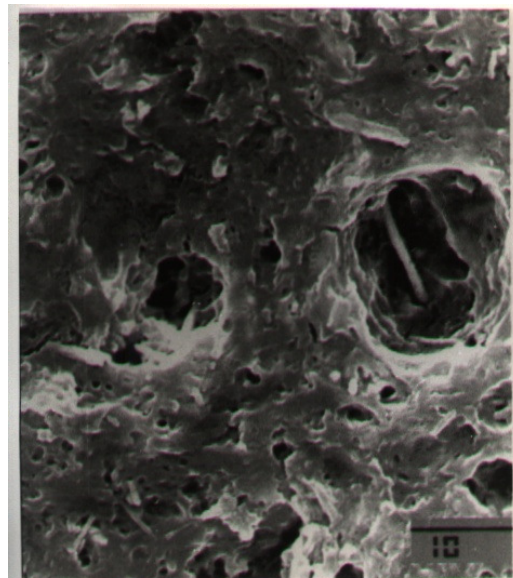
Fig.3. Scanning electron micrograph of a corroded AISI 430 SS after 20 days of exposure x 5000

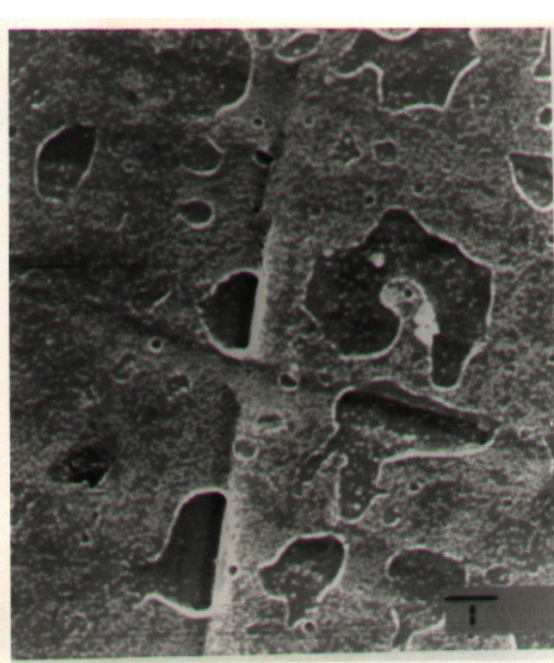
Fig.4. Scanning electron micrograph of a corroded AISI 304 SS after 20 days of exposure x 1000

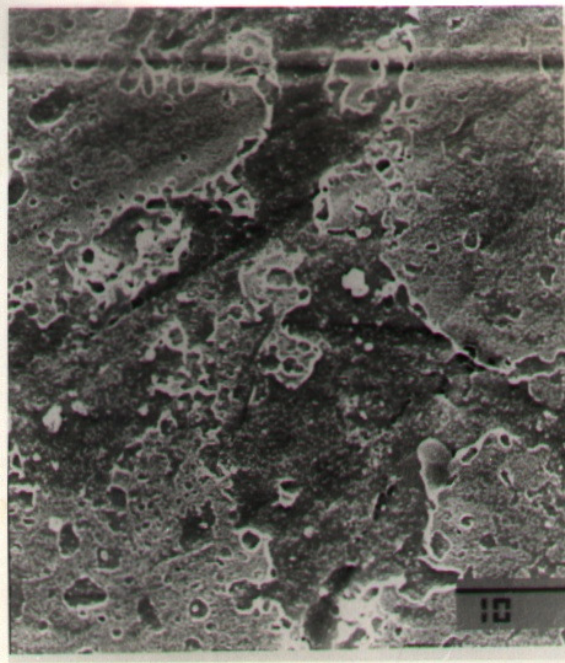
Fig.5. Scanning electron micrograph of a corroded AISI 321 SS after 20 days of exposure x 5000

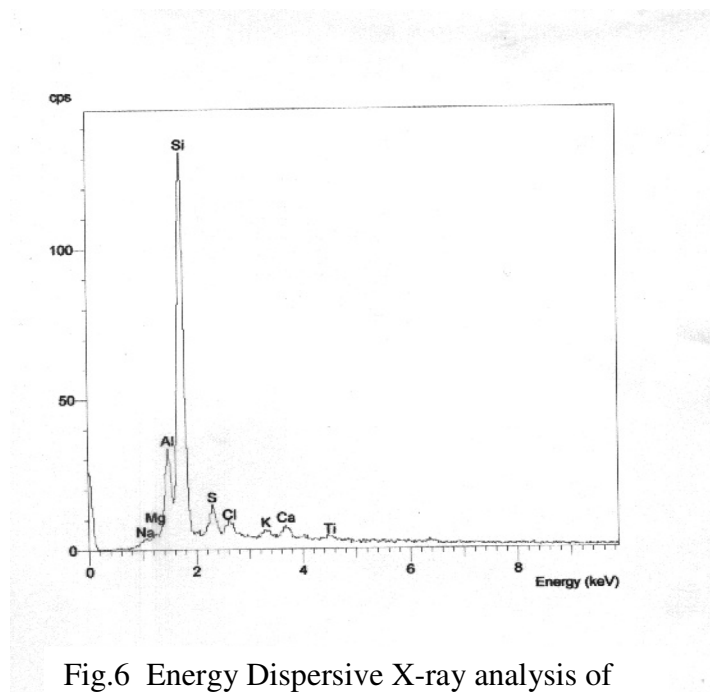
Fig.6 Energy Dispersive X-ray analysis of Nigerian rich tar sand.

The stainless steels used in this work were obtained from a metal scrap market at Owode Onirin in Ikorodu, Lagos. Two of them are austenitic stainless steels of types AISI 304 and AISI 321 and a ferritic grade-AISI 430. The chemical compositions of these stainless steels are contained in Table 1. The lumps of Nigeria rich tar sand used for this work were obtained from a town called Agbabu in Ondo State around where Nigeria has a large deposit of tar sand. The energy dispersive X-ray analysis of the Nigerian rich tar sand used for investigation is as contained in Table 2 and Fig.6.

From the results of the analysis of some Nigerian tar sand bitumen by Oluwole et al(1980) and as evident for some of the elements in Fig.6 it is clear that the tar sand environment contains in traces the following elements calcium, iron, potassium, magnesium, sodium, nickel and vanadium. All these elements apart from nickel and vanadium are more base (i.e. more active) than iron/steel because of their positions in the electrochemical series or the galvanic series. The quantities of vanadium and the vanadium to nickel ratio quoted in the analysis show that these elements are present in significant amount. In a corrosion environment like that of tar sand bitumen it is suspected that numerous galvanic cells would have been set up between iron of steel and the vanadium and nickel metals present in tar sand. And the iron/steel because of its position in the galvanic series would be anodic while trace metals (V and Ni) will be cathodic. The corrosion reactions between the three elements in the tar sand environment can be therefore be written as
