Study on Ground-Penetrating Radar (GPR) Application in Pavement Deep Distress Detection

Songtao Li^{1,2}, Chengchao Guo^{1,3*}

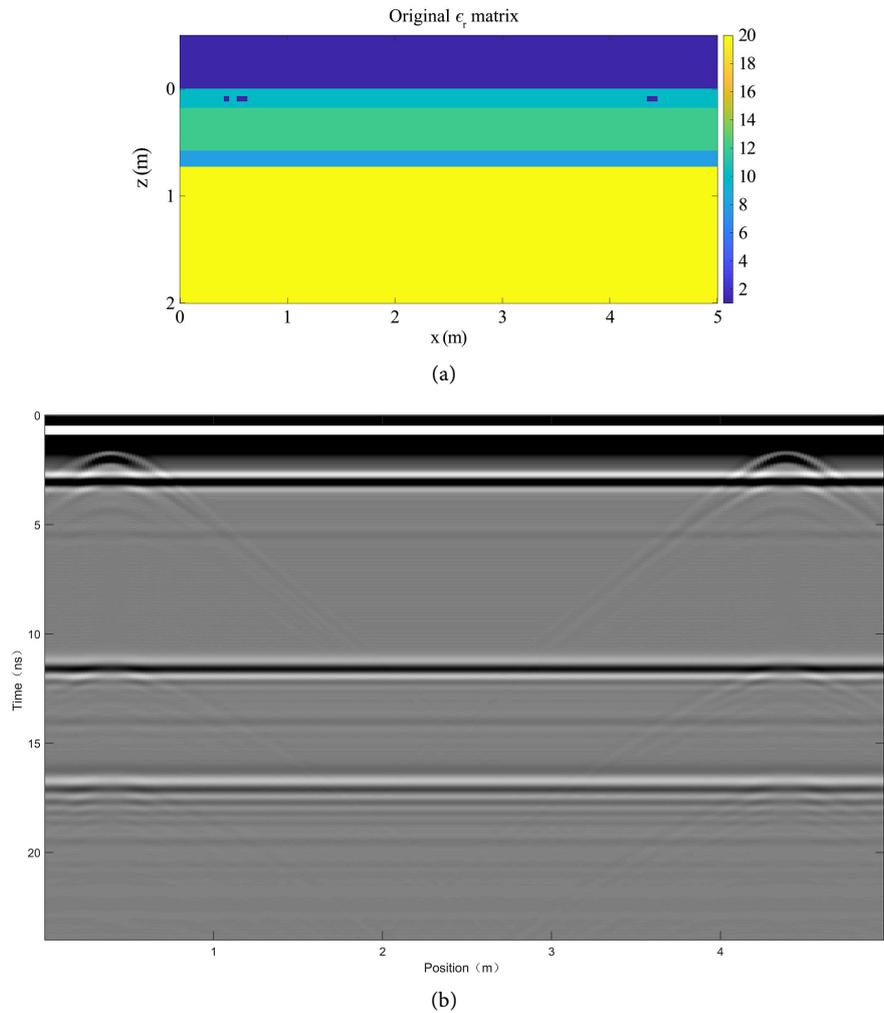
Case 1: The dielectric model of pavement with locally undercompacted surface course is shown in **Figure 1(a)**, and several layers are contained in the model, *i.e.*, air layer, surface course, base course, subbase course and subgrade. Three undercompacted zones are presented in surface course with the dimension of 1 cm \times 1 cm, 1 cm \times 3 cm and 1 cm \times 5 cm respectively, and the corresponding reflected wave image is illustrated in **Figure 1(b)**.

Figure 1. (a) Dielectric model of pavement with locally undercompacted surface course; (b) Reflected wave of model 1a.

As can be seen from **Figures 1-3**, when electromagnetic waves propagated into the dielectric model with voids or undercompacted zones, the reflected wave images would report the variation at the position with defects. Particularly, defects with relatively smaller dimension, e.g., 1 cm \times 1 cm in **Figure 1(a)**, could be detected with acquired reflected waves. Due to the close range between two

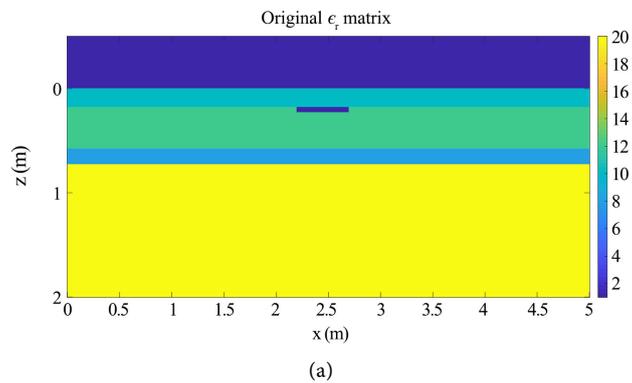
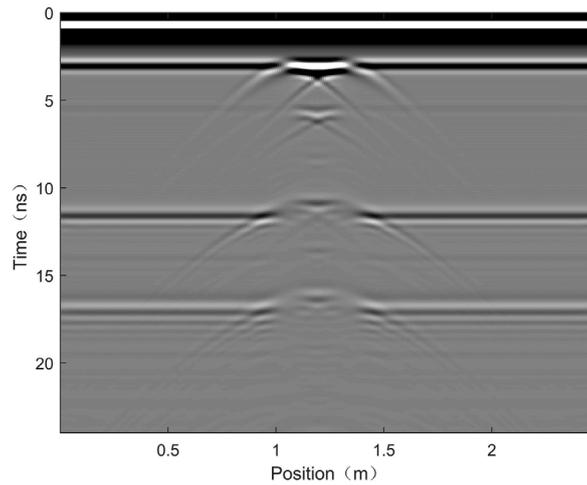
Case 2: The dielectric model of pavement with voids in the bottom of surface course is shown in **Figure 2(a)**, and the defect dimension was 5 cm \times 50 cm. Voids were filled with air, and the corresponding reflected wave is illustrated in **Figure 2(b)**.

Figure 2. (a) Dielectric model of pavement with voids filled with air in surface course; (b) Reflected wave of model 2a.

defects, the reflected waves interfered mutually, and a superposed wave was generated. Moreover, with the larger dimension of models shown in **Figure 2** and **Figure 3**, stronger reflected waves were obtained. As the dielectric constant increased with the presence of moisture, stronger reflected waves appeared, as shown in **Figure 3**.

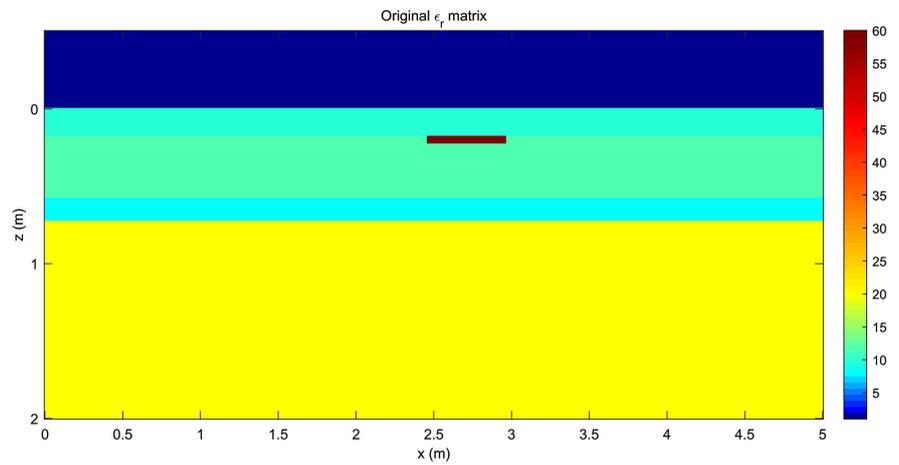
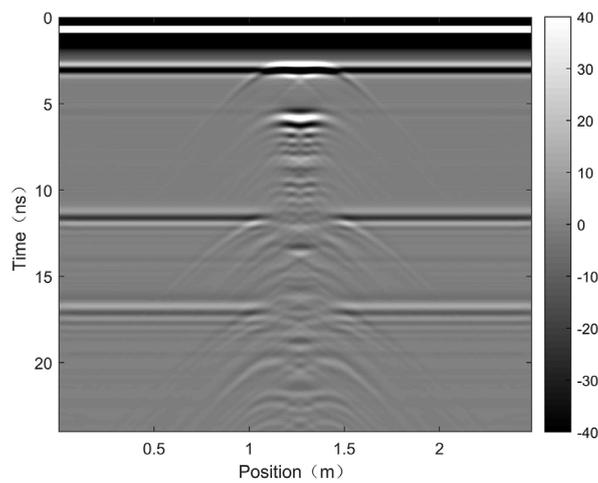
Case 3: The dielectric model of pavement with voids in the bottom of surface course is shown in **Figure 3(a)**, and the defect dimension was 5 cm \times 50 cm. Voids were filled with water, and the corresponding reflected wave is illustrated in **Figure 3(b)**.

Figure 3. (a) Dielectric model of pavement with voids filled with water in surface course; (b) Reflected wave of model 3a.

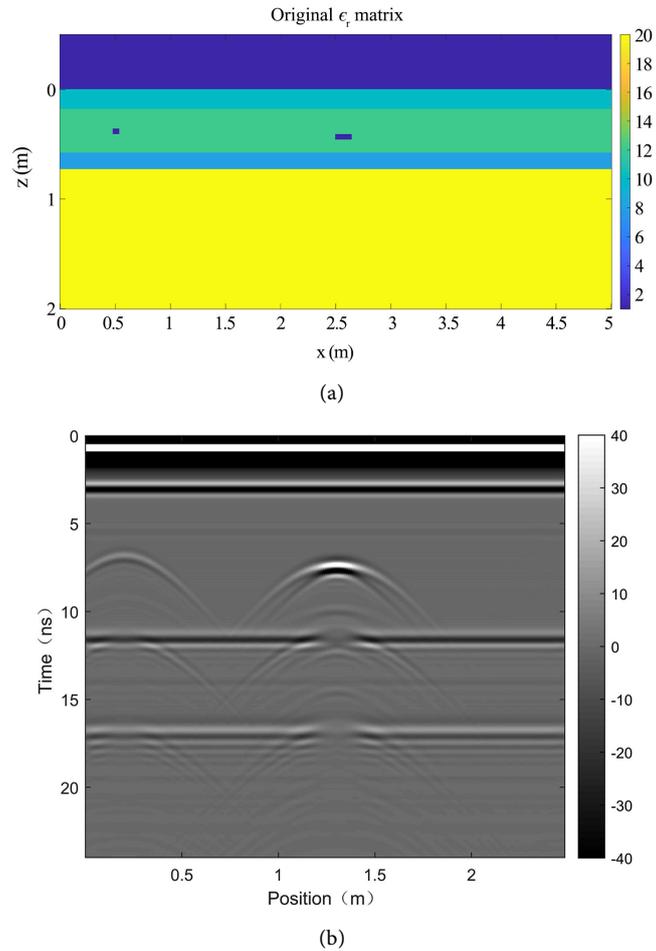
Case 4: The dielectric model of pavement with locally undercompacted base is shown in **Figure 4(a)**, and the defect dimensions were 1 cm × 1 cm and 1 cm × 10 cm. The corresponding reflected wave is shown in **Figure 4(b)**.

Figure 4. (a) Dielectric model of pavement with voids filled with water in surface course; (b) Reflected wave of model 4a.

It can be seen from **Figures 4-6** that reflected images varied with the width and length of voids or undercompacted zones in base. The scope and area could be quantitatively identified based on the images approximately. The reflected waves varied from weak to strong as the voids became filled with water instead of air, and the intensity of reflected waves induced by undercompacted zones lay between that of the two cases. If two defects were at a certain spacing, reflected maps could not interfere mutually, e.g., Case 4.

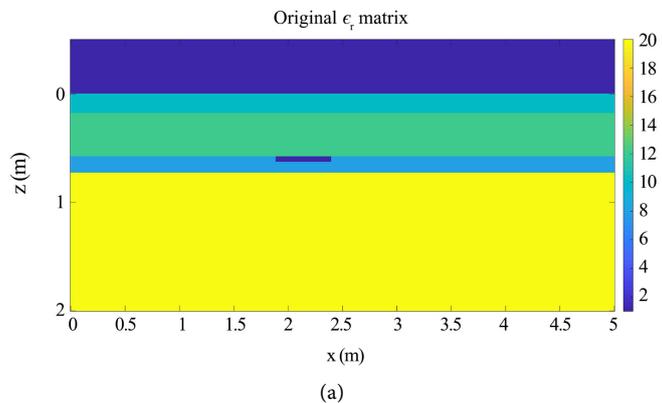
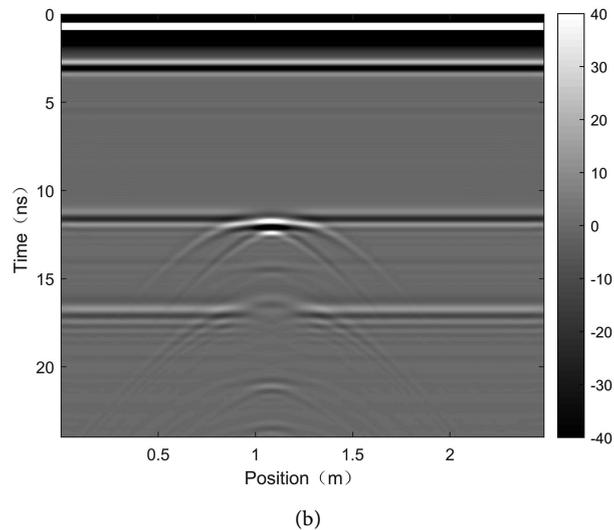
Case 5: The dielectric model of pavement with voids in the base bottom is shown in **Figure 5(a)**, and the defect dimension was 5 cm × 50 cm. Voids were filled with air, and the corresponding reflected wave is illustrated in **Figure 5(b)**.

Figure 5. (a) Dielectric model of pavement with voids filled with water air in base; (b) Reflected wave of model 5a.

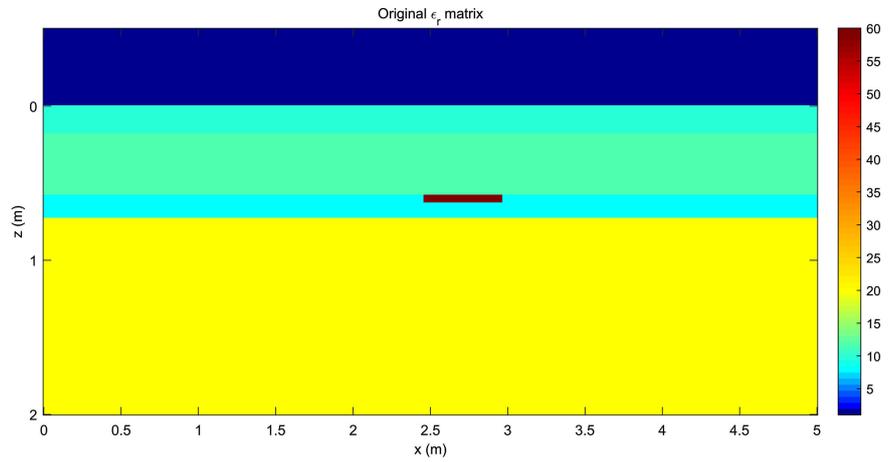
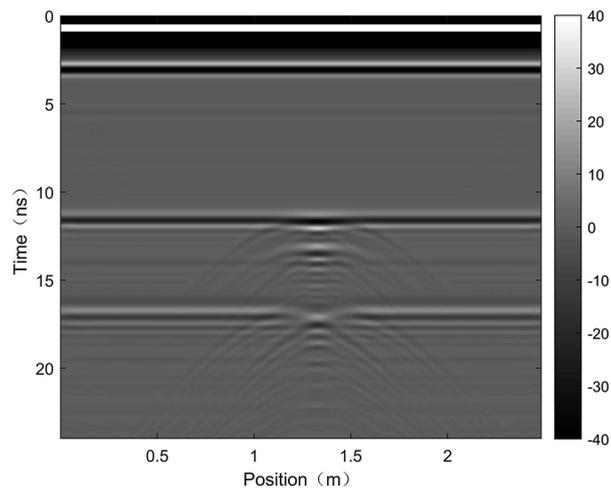
Case 6: The dielectric model of pavement with voids in the base bottom is shown in **Figure 6(a)**, and the dimension of defect was $5\text{ cm} \times 50\text{ cm}$. Voids were filled with water, and the corresponding reflected wave is illustrated in **Figure 6(b)**.

Figure 6. (a) Dielectric model of pavement with voids filled with water air in base; (b) Reflected wave of model 6a.

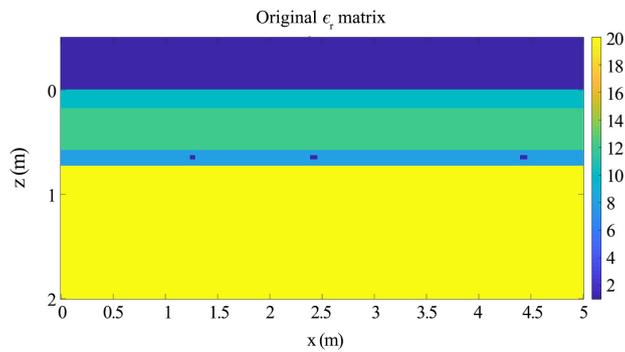
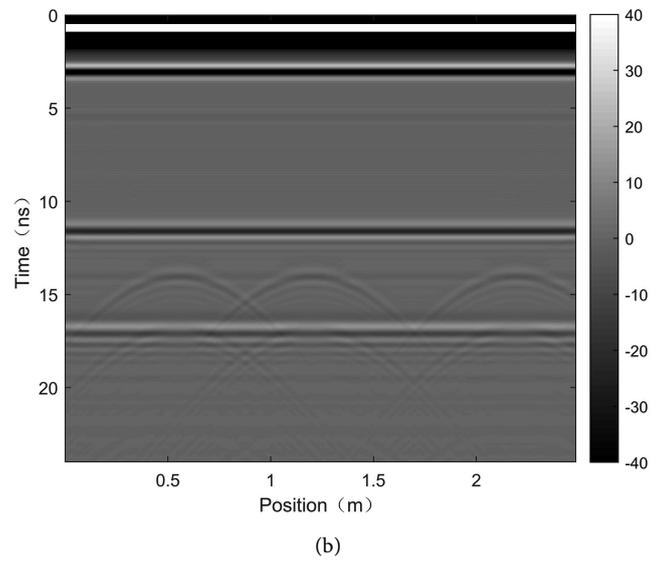
Case 7: The dielectric model of pavement with locally undercompacted sub-base is shown in **Figure 7(a)**, and the defect dimensions were $1\text{ cm} \times 1\text{ cm}$, $1\text{ cm} \times 3\text{ cm}$ and $1\text{ cm} \times 3\text{ cm}$ respectively at different positions. The corresponding reflected image is shown in **Figure 7(b)**. With regard to **Figure 7**, it is supposed that three defects were located in subbase course, and three abnormal reflections could be identified at corresponding positions.

Figure 7. (a) Dielectric model of pavement with locally undercompacted subbase; (b) Reflected wave of model 7a.

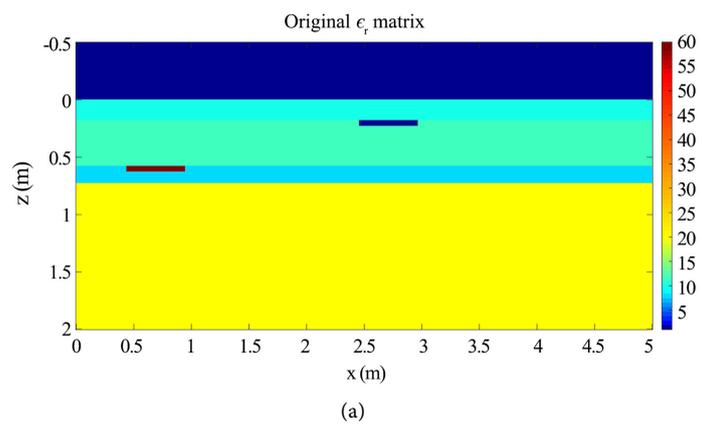
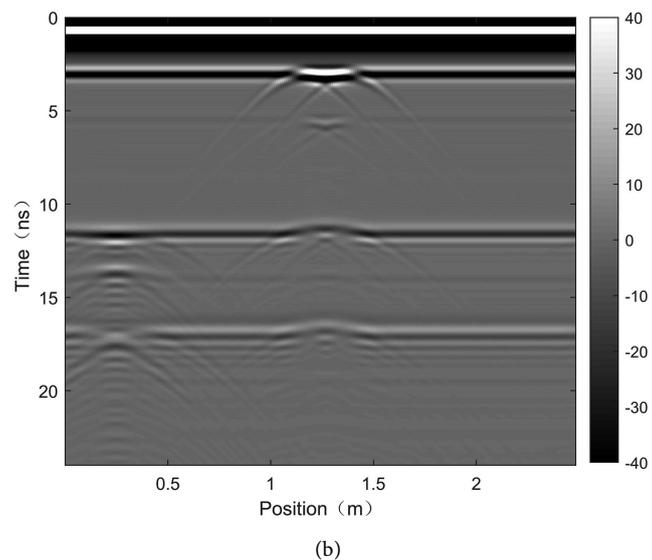
Case 8: The coupled dielectric model of pavement with coupled voids in surface course and base bottom. The voids were filled with air and water respectively, as shown in **Figure 8(a)**, and the void dimension was $5\text{ cm} \times 50\text{ cm}$. The corresponding reflected wave is shown in **Figure 8(b)**. The different positions cannot be identified by abnormal reflection, while the coupled distresses could be revealed through the image. Besides, the defect property could also be investigated by reflection intensity briefly.

Figure 8. (a) Dielectric model of pavement with coupled voids in surface course and base bottom; (b) Reflected wave of model 8a.

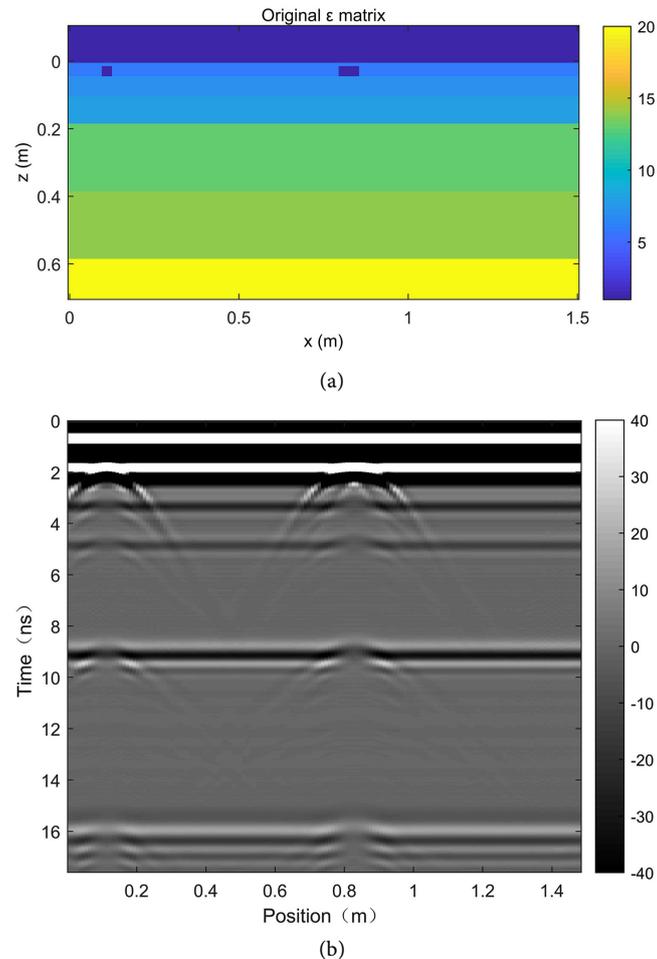
Case 1: The dielectric model of pavement with locally undercompacted zones in the surface course top is shown in **Figure 9(a)**. Two undercompacted zones were contained with the dimension of 1 cm \times 1 cm and 1 cm \times 3 cm respectively, and the corresponding reflected wave image is shown in **Figure 9(b)**. With the same defect dimension, the range of the reflected wave was larger than that of 400 MHz. Thus, based on 900 MHz antenna, the detection with higher accuracy could be obtained, *i.e.*, smaller defects could also be identified generally.

Figure 9. (a) Dielectric model of pavement with undercompacted surface top; (b) Reflected wave of model 9a.

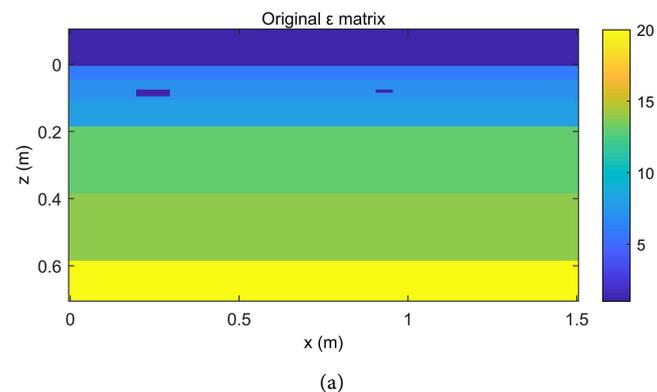
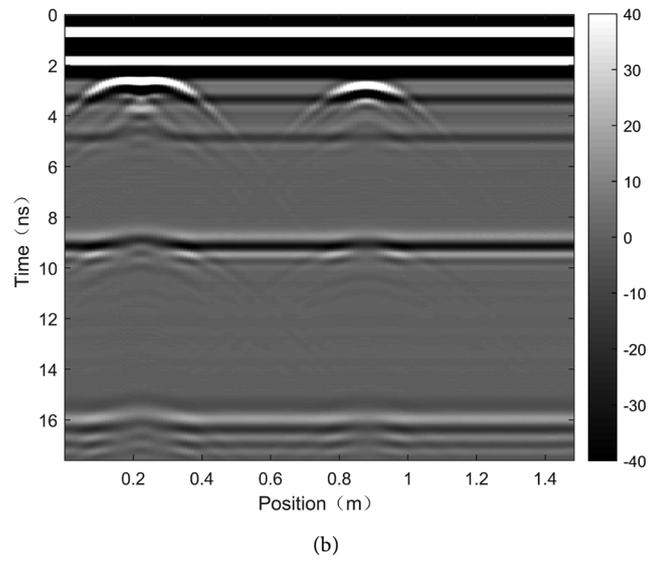
Case 2: The dielectric model of pavement with locally undercompacted zones in the intermediate surface course is shown in **Figure 10(a)**. The two small undercompacted zones were contained with the dimension of 0.5 cm \times 10 cm and 0.25 cm \times 5 cm respectively. The corresponding reflected wave image is shown in **Figure 10(b)**. Although the target defects became smaller, they still could be detected through the reflected wave image with higher frequency propagation.

Figure 10. (a) Dielectric model of pavement with undercompacted intermediate surface; (b) Reflected wave of model 10a.

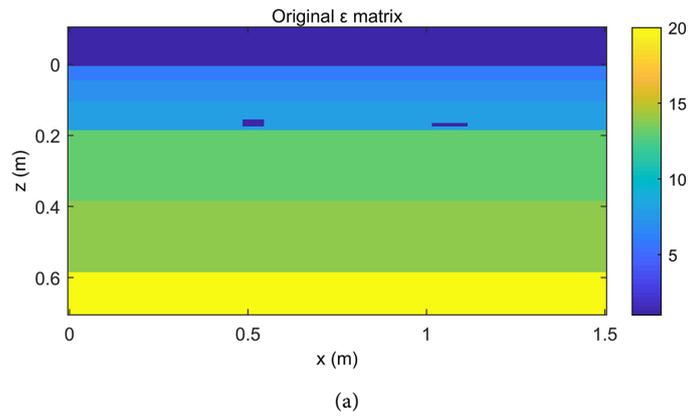
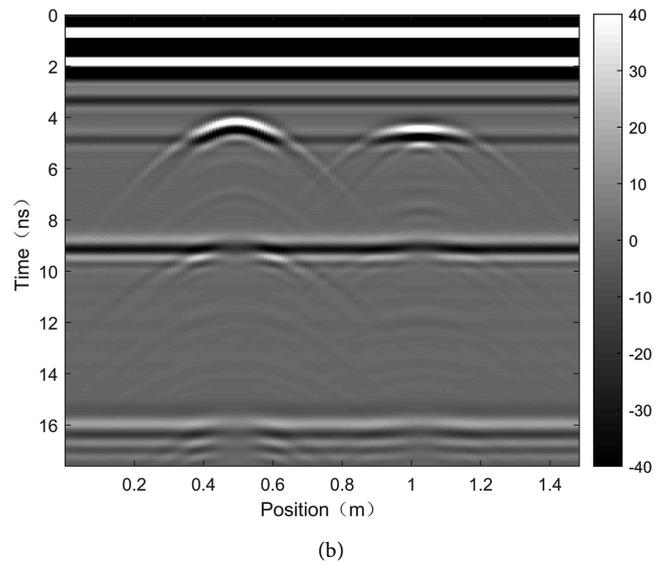
Case 3: The dielectric model of pavement with locally undercompacted zones in the surface course bottom is shown in **Figure 11(a)**. Two undercompacted zones existed with the dimension of 0.5 cm \times 5 cm and 0.25 cm \times 10 cm respectively, and the corresponding reflected wave image is shown in **Figure 11(b)**. Defects position and the dimension (*i.e.*, width and length) of the model in the Case 3 varied compared with that Case 2, while the simulation images were similar acquired in Case 2 and 3.

Figure 11. (a) Dielectric model of pavement with undercompacted surface bottom; (b) Reflected wave of model 11a.

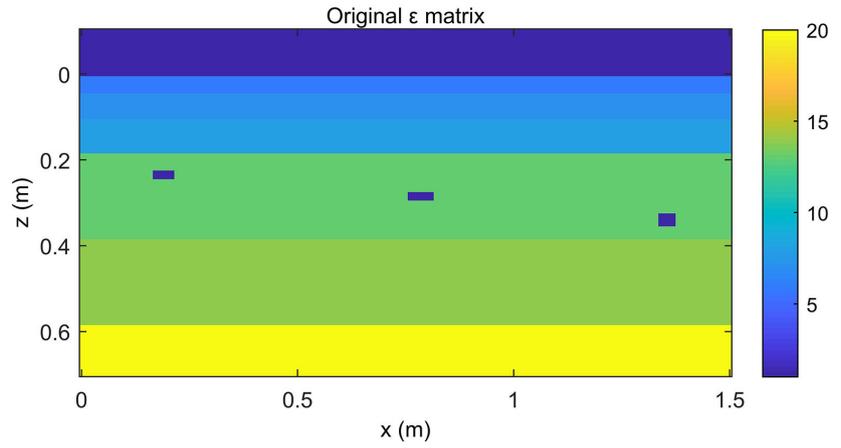
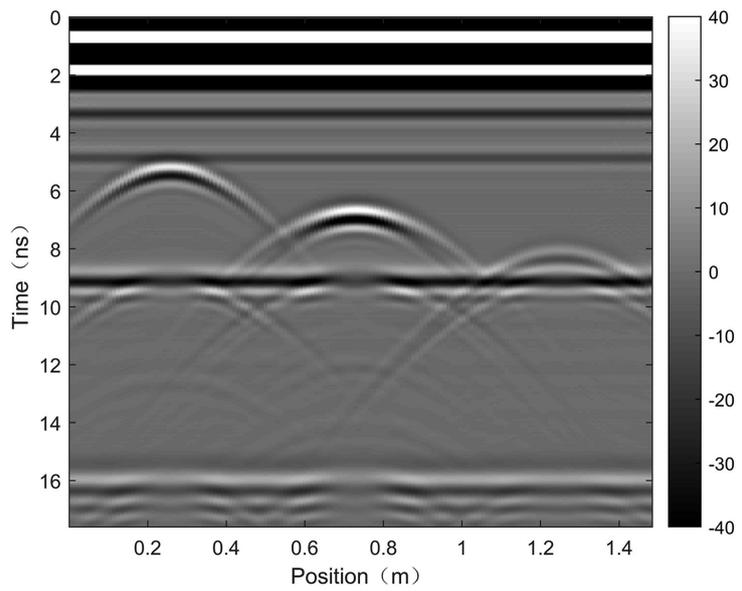
Case 4: The dielectric model of pavement with locally undercompacted zones in the base top is shown in **Figure 12(a)**. Three abnormal zones were contained with the dimension of 0.5 cm \times 3 cm, 0.5 cm \times 5 cm and 1 cm \times 1 cm respectively, and the corresponding reflected wave image is shown in **Figure 12(b)**.

Figure 12. (a) Dielectric model of pavement with undercompacted base top; (b) Reflected wave of model 12a.

It is shown that the detection depth of 900 MHz decreased, while the detection accuracy increased, higher than that of 400 MHz. Therefore, the target defects contained in deeper layers, could also be identified through reflected wave images, e.g., **Figure 12(b)** and **Figure 13(b)**.

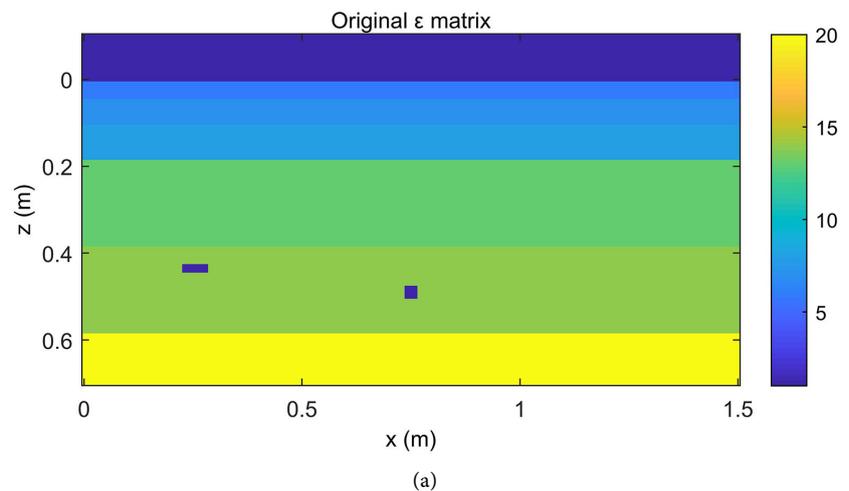
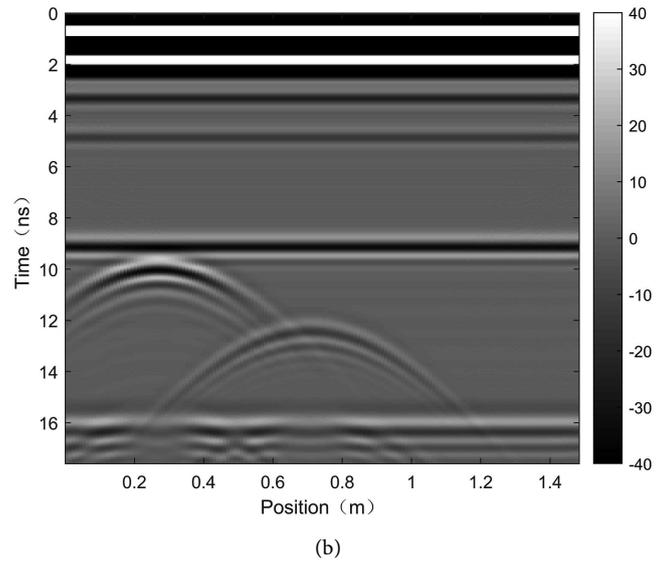
Case 5: The dielectric model of pavement with locally undercompacted zones in the base bottom is shown in **Figure 13(a)**. Two undercompacted zones ex-

isted with the dimension of $0.25 \text{ cm} \times 3 \text{ cm}$ and $1 \text{ cm} \times 1 \text{ cm}$ respectively, and the corresponding reflected wave image is shown in **Figure 13(b)**.

Figure 13. (a) Dielectric model of pavement with undercompacted base bottom; (b) Reflected wave of model 13a.

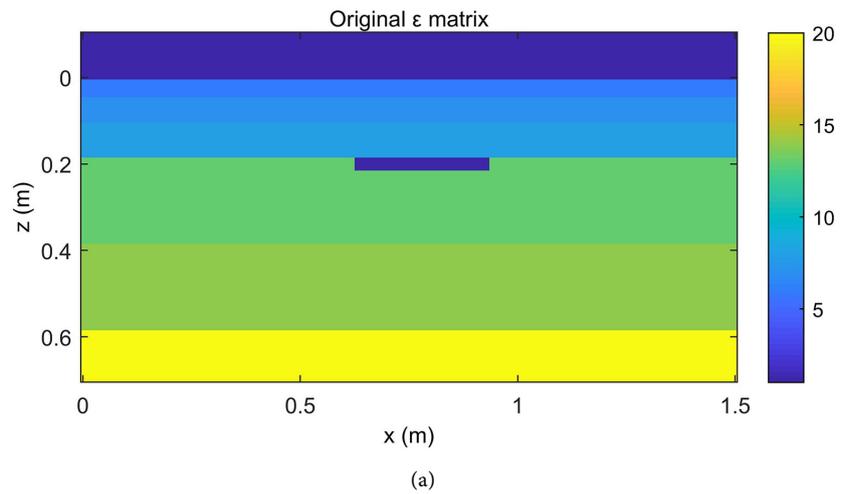
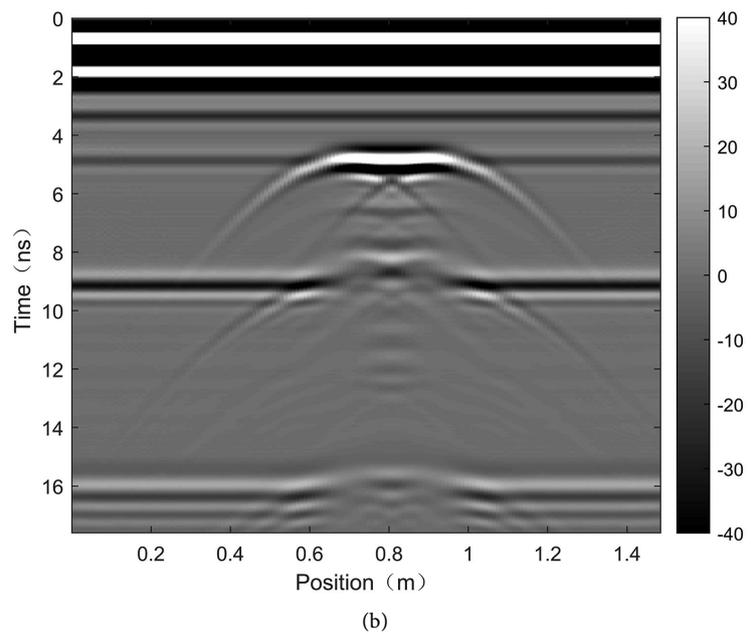
Case 6: The dielectric model of pavement with poor bonding between base and surface course is shown in **Figure 14(a)**. One distress was contained in the model with the dimension of 1 cm × 15 cm, and the corresponding reflected wave image is shown in **Figure 14(b)**.

Figure 14. (a) Dielectric model of pavement with poor surface-base bonding; (b) Reflected wave of model 14a.

As can be seen from Case 6 - Case 8, the set bonding conditions got weaker from the top to the bottom of pavement structures, while the defects still could generally be revealed through the simulation wave images.

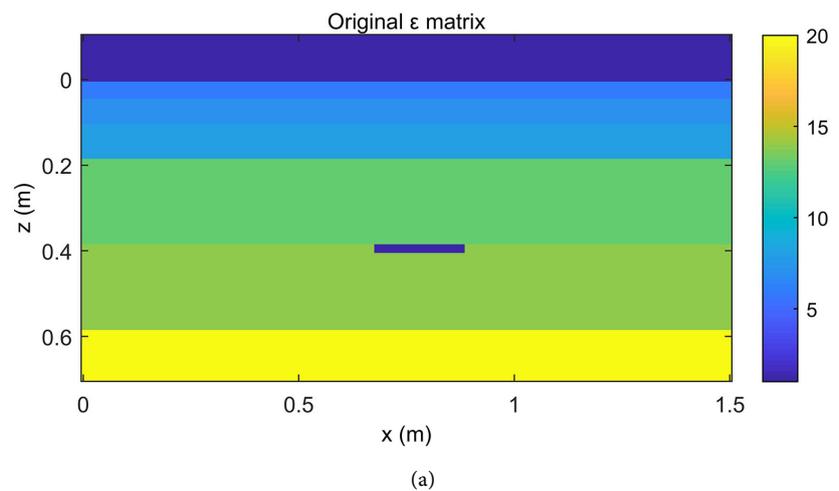
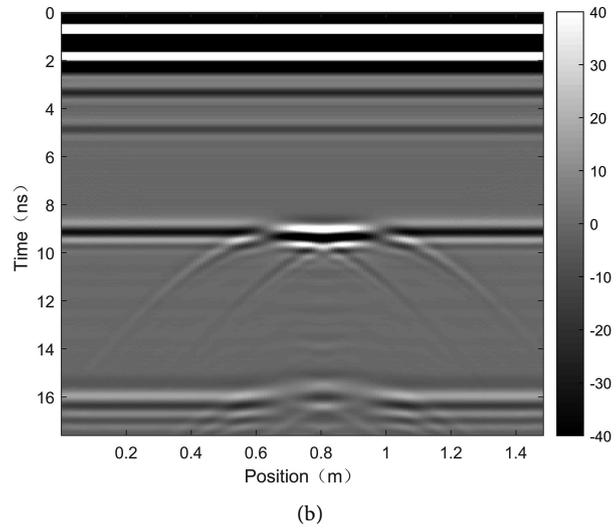
Case 7: The dielectric model of pavement with poor bonding between base and subbase is shown in **Figure 15(a)**. One distress existed with the dimension of 0.5 cm × 15 cm, and the corresponding reflected image is shown in wave **Figure 15(b)**.

Figure 15. (a) Dielectric model of pavement with poor bonding between base and sub-base; (b) Reflected wave of model 15a.

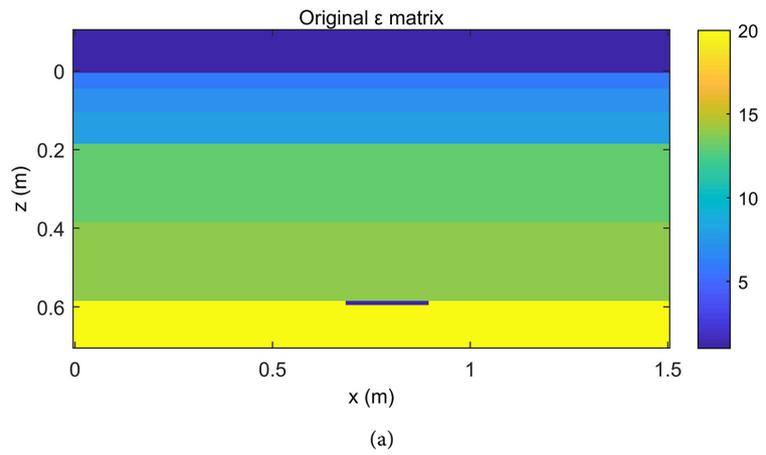
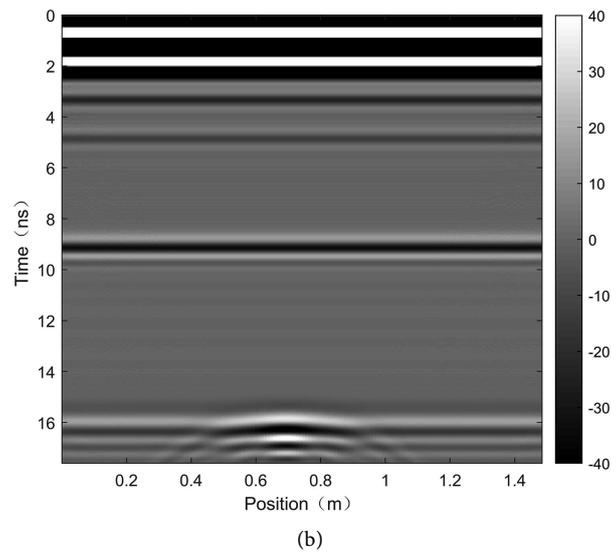
Case 8: The dielectric model of pavement with poor bonding between subbase and subgrade is shown in **Figure 16(a)**. One distress existed with the dimension of 0.25 cm × 15 cm, and the corresponding reflected wave image is shown in **Figure 16(b)**.

Figure 16. (a) Dielectric model of pavement with poor subbase-subgrade bonding; (b) Reflected wave of model 16a.

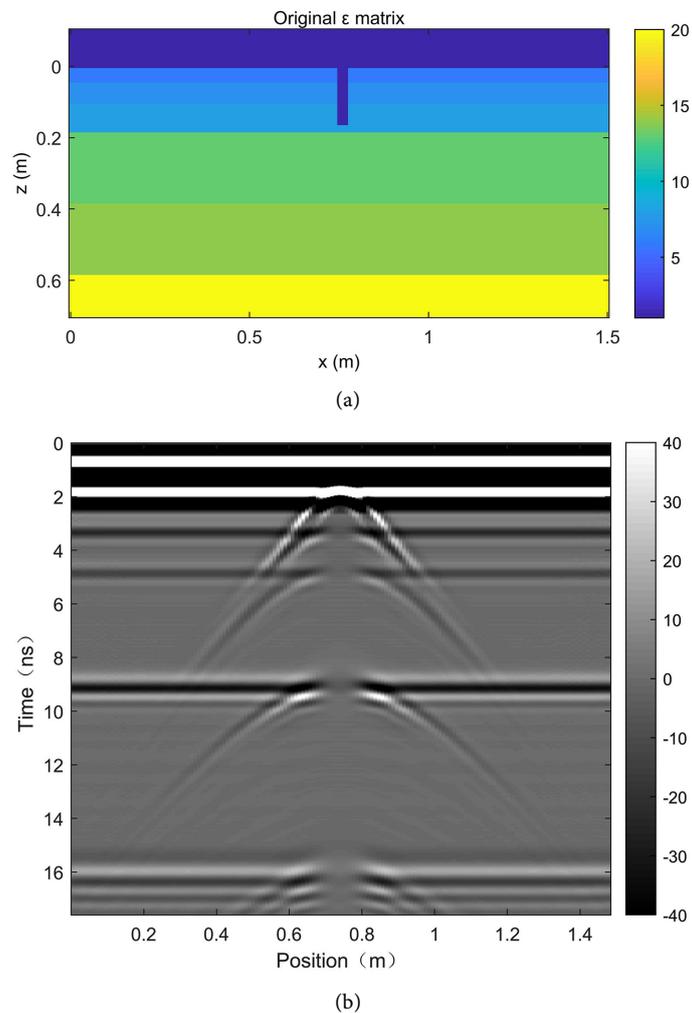
Case 9: The dielectric model of pavement with a crack in surface course is shown in **Figure 17(a)**. One distress (*i.e.*, a vertical crack) existed with the dimension of 15 cm × 1 cm. The corresponding reflected wave is shown in **Figure 17(b)**, and it indicates that the vertical crack could also be identified through the reflected wave image.

Figure 17. (a) Dielectric model of pavement with crack in surface course; (b) Reflected wave of model 17a.

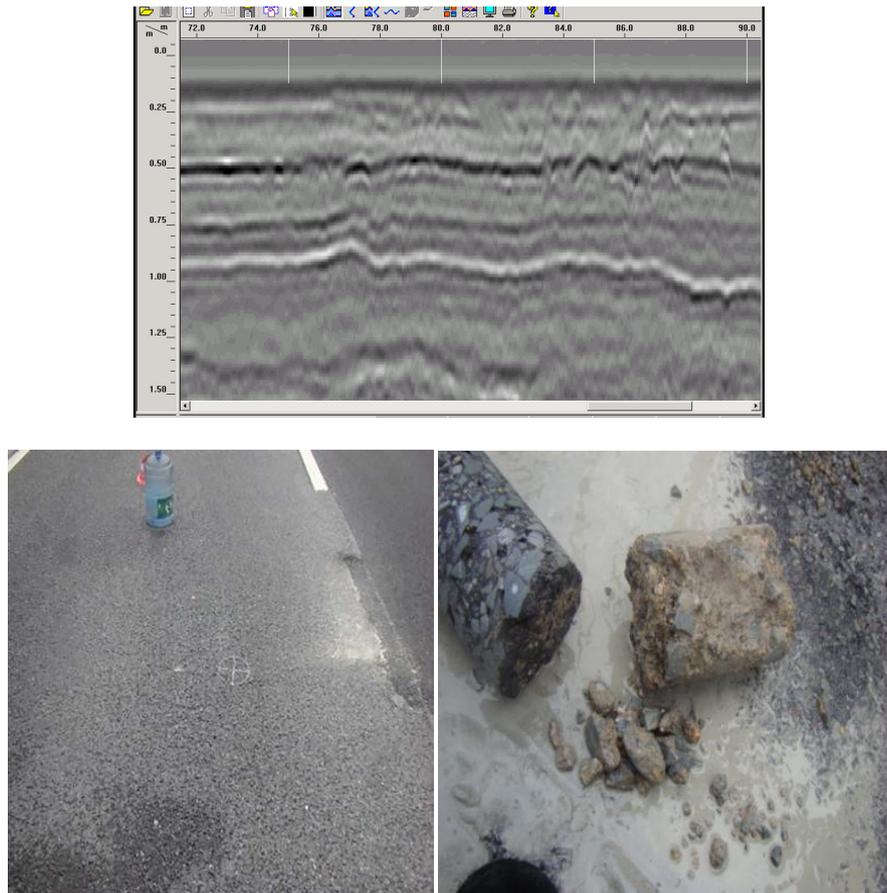
The GPR image, pavement surface before coring and coring sample near K2876 + 082 (*i.e.*, test point) are shown in **Figure 18**. The pavement surface was in a relatively good condition except a small transverse crack. It can be seen from the GPR image that the surface course was nearly integrated from +076 to +090, while the bond between surface course and base was poor. Besides, moist and loose zones were also identified in the subgrade. At +078, a crack ran the length of the base. The coring samples from various layers (*i.e.*, the relatively integrated surface course, base with cracks, and loose zones between surface course and base) got good agreement with the acquired results from GPR images.

Figure 18. GPR image and coring sample at K2876 + 078 of upward carriageway.

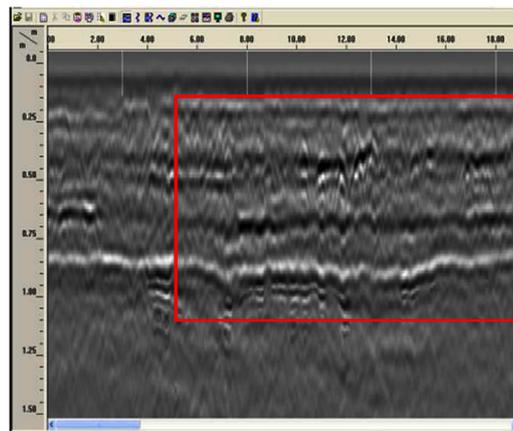
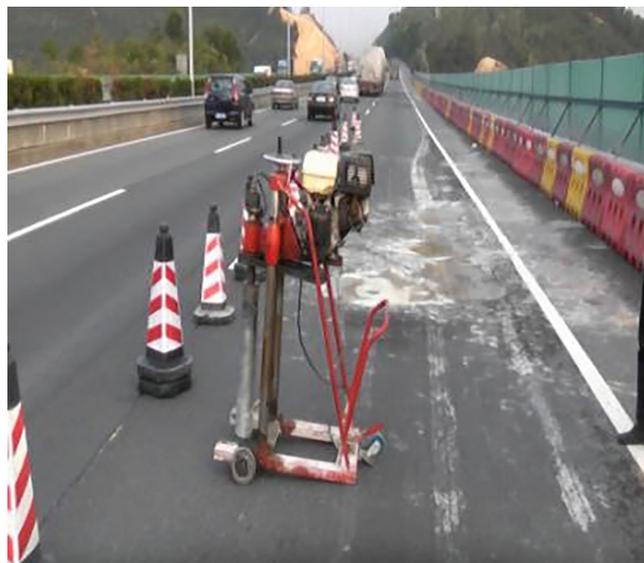
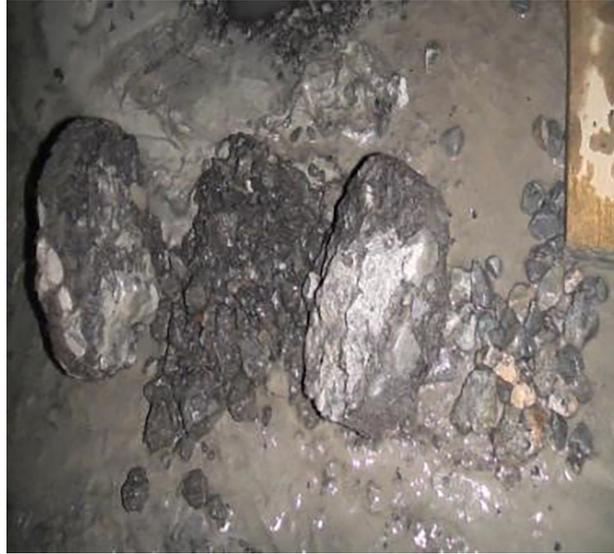
Similarly, another test at K2878 + 010 was performed, as shown in **Figure 19**. The pavement surface course contained no distresses before coring, while, it can be seen from the GPR image that the surface course was partly integrated from +003 to +018. Besides, the bond between surface course and base was poor, and the loose zones were generated in the base and subbase. Particularly, both moist and loose zones existed in the subgrade. The coring samples from various layers (*i.e.*, the partly integrated surface course, the loose and poor bonding base) got good agreement with the acquired results from GPR images.

Figure 19. GPR image and coring sample at K2878 + 010 of downward carriageway.

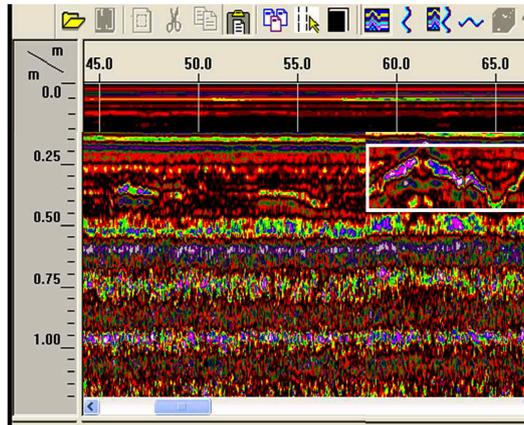
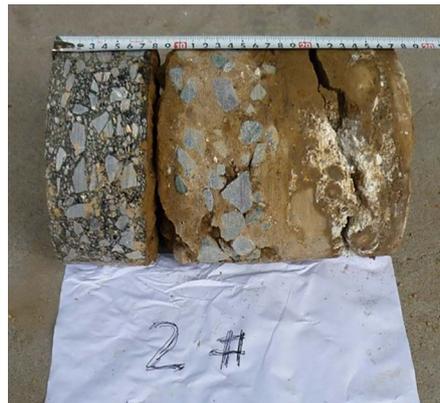
The surface course in the left side of left lane was severely damaged and fragmented, whose GPR images and coring samples are shown in **Figure 20**. It can be seen from the GPR image that the lime stabilized soil gravel base was loose and undercompacted, and some interlayers were also contained. The core sampling demonstrated that the thickness of surface course was insufficient, and some defects existed in the base. Although the surface course got destructed, the actual distress lay in the deep base.

Figure 20. GPR image and coring sample at K1 + 062 in the left side of left lane.

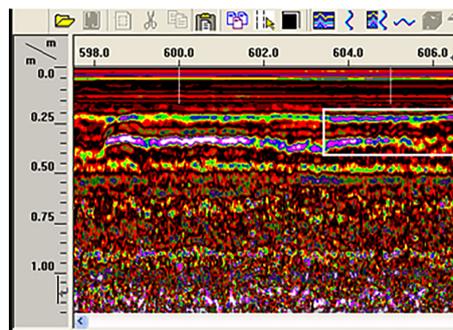
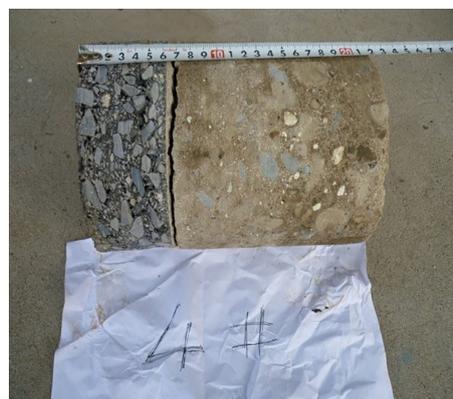
The surface course in right side of right lane was slightly damaged, whose GPR images and coring samples are shown in **Figure 21**. It can be seen from **Figure 21** that the lime stabilized soil gravel base was nearly integrated, and some loose zones were created in lime stabilized soil subbase. The bond between surface course and base was poor, and the bond between base and subbase was also poor. The core sampling revealed that the thickness of surface course was insufficient, and the surface course and base was detached. Therefore, it can be seen from the GPR image that the induced distresses existed in deep base or subbase, besides the surface diseases.

Figure 21. GPR image and coring sample at K0 + 602 in right side of right lane.

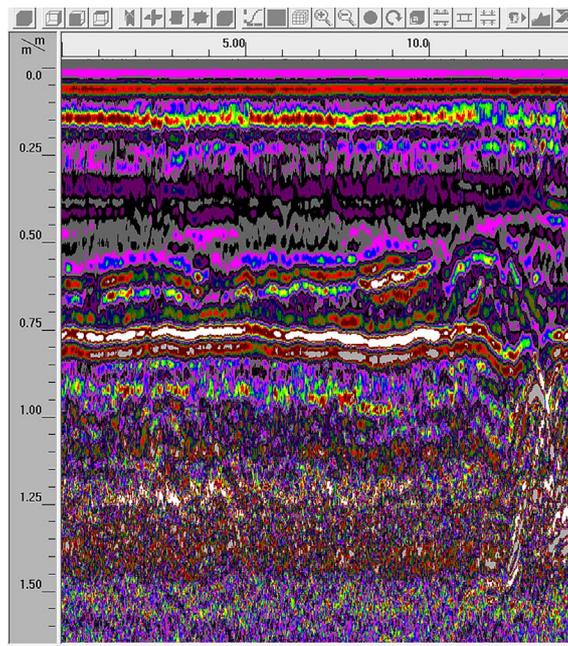
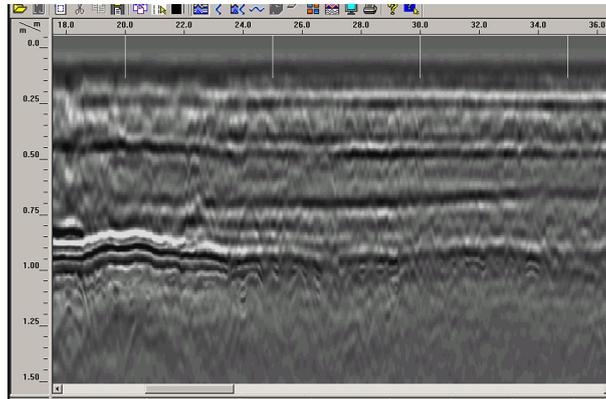
The GPR images at K2900 + 600 - K2900 + 615 of upward carriageway in Shenzhen Expressway from airport to Heao are presented in **Figure 22**. From K2900 + 603 to K2900 + 615 at the depth range of 0.18 - 0.22 m, 0.45 - 0.6 m and 0.60 - 0.85 m, the abnormal zones were illustrated in **Figure 22**. Furthermore, some defects were determined lying in the base and subbase, and photos of the corresponding layers with defects are shown in **Figure 23** and **Figure 24**.

Figure 22. GPR image at K2900 + 600 - K2900 + 615 of upward carriageway.

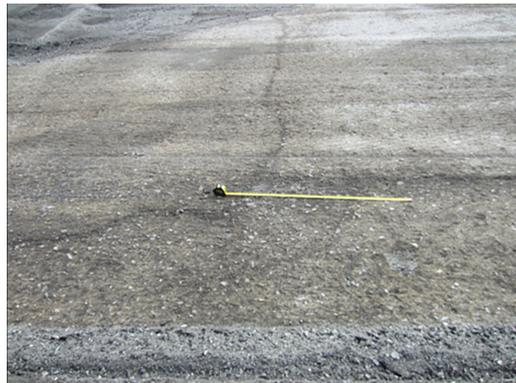
Some defects (e.g., longitudinal cracks, transverse cracks, block, loose zones, and local infiltration) could be seen from **Figure 23**. The loose zones and local infiltration could be found in **Figure 24**. Therefore, the deep defects in base and subbase could be identified by GPR quite probably.

Figure 23. Photo of top base at K2900 + 605 - K2900 + 610.

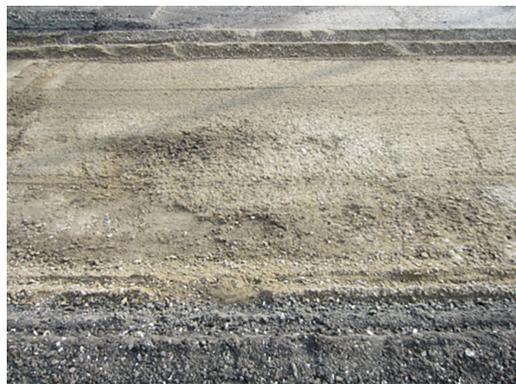
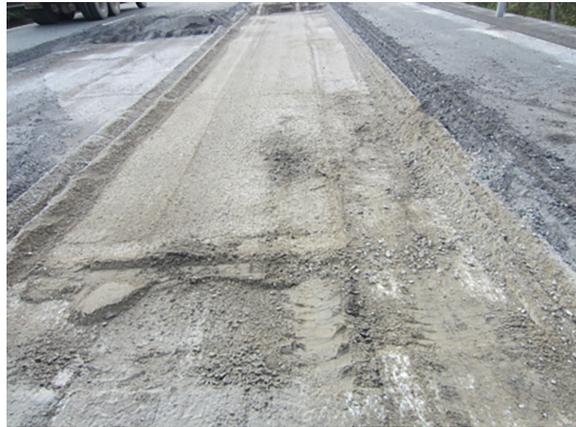
Figure 24. Photo of top subbase at K2900 + 605 - K2900 + 610.

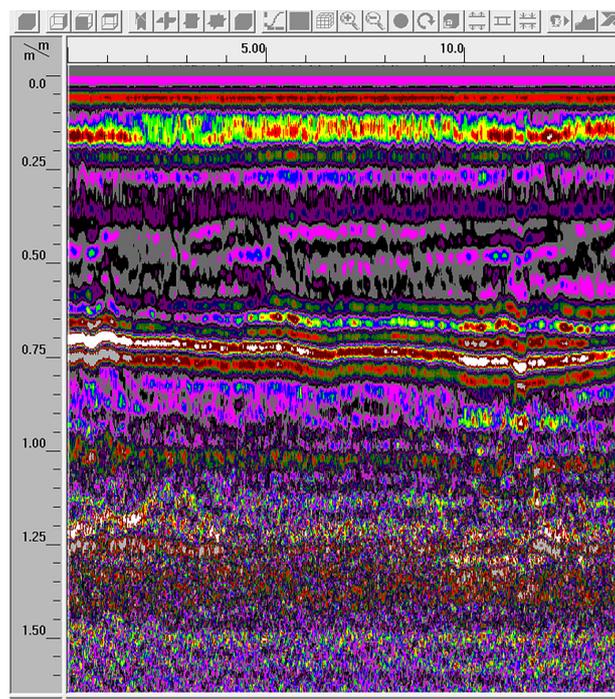
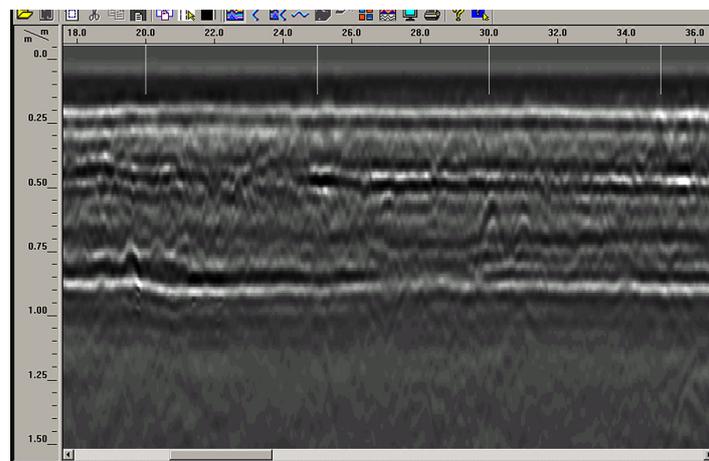
The GPR image at K2902 + 980 - K2903 + 000 of upward carriageway in Shenzhen expressway from airport to Heao is shown in **Figure 25**. From K2902 + 985 to K2902 + 999 at the depth range of 0.18 - 0.23 m, 0.4 - 0.6 m and 0.60 - 0.75 m. Some abnormal sections are presented in **Figure 25**. Some defects were determined lying in the base and subbase, and photos of the corresponding layers with defects are shown in **Figure 26** and **Figure 27**.

Figure 25. GPR image at K2902 + 980 - K2903 + 000 of upward carriageway.

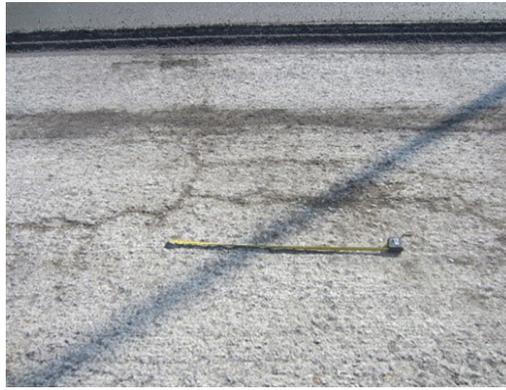
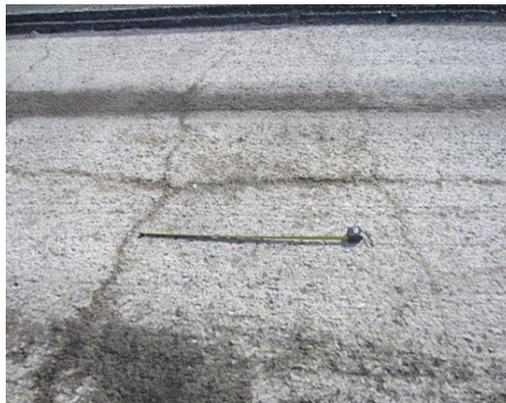
Some defects (e.g., longitudinal cracks, transverse cracks, block, loose zones, and local infiltration) could be seen from **Figure 26**. The loose zones and local infiltration could be found in **Figure 27**. Therefore, the deep defects in base and subbase could be identified by GPR quite probably.

Figure 26. Photo of top base at K2900 + 605 - K2900 + 610.

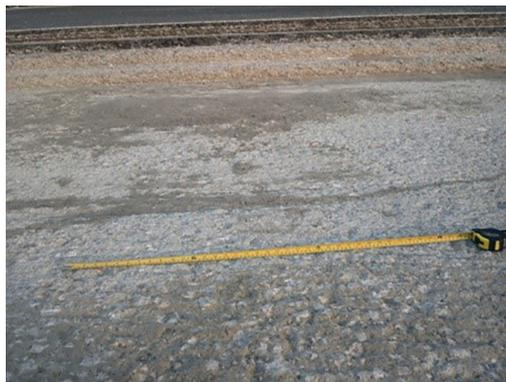
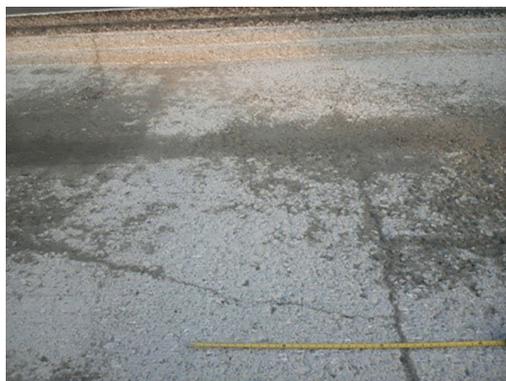
Figure 27. Photo of top subbase at K2900 + 605 - K2900 + 610.
