Drainage Management Problems Evaluation: Case Study Baloza and EL-Farama Drains, North Sinai, Egypt

Abstract

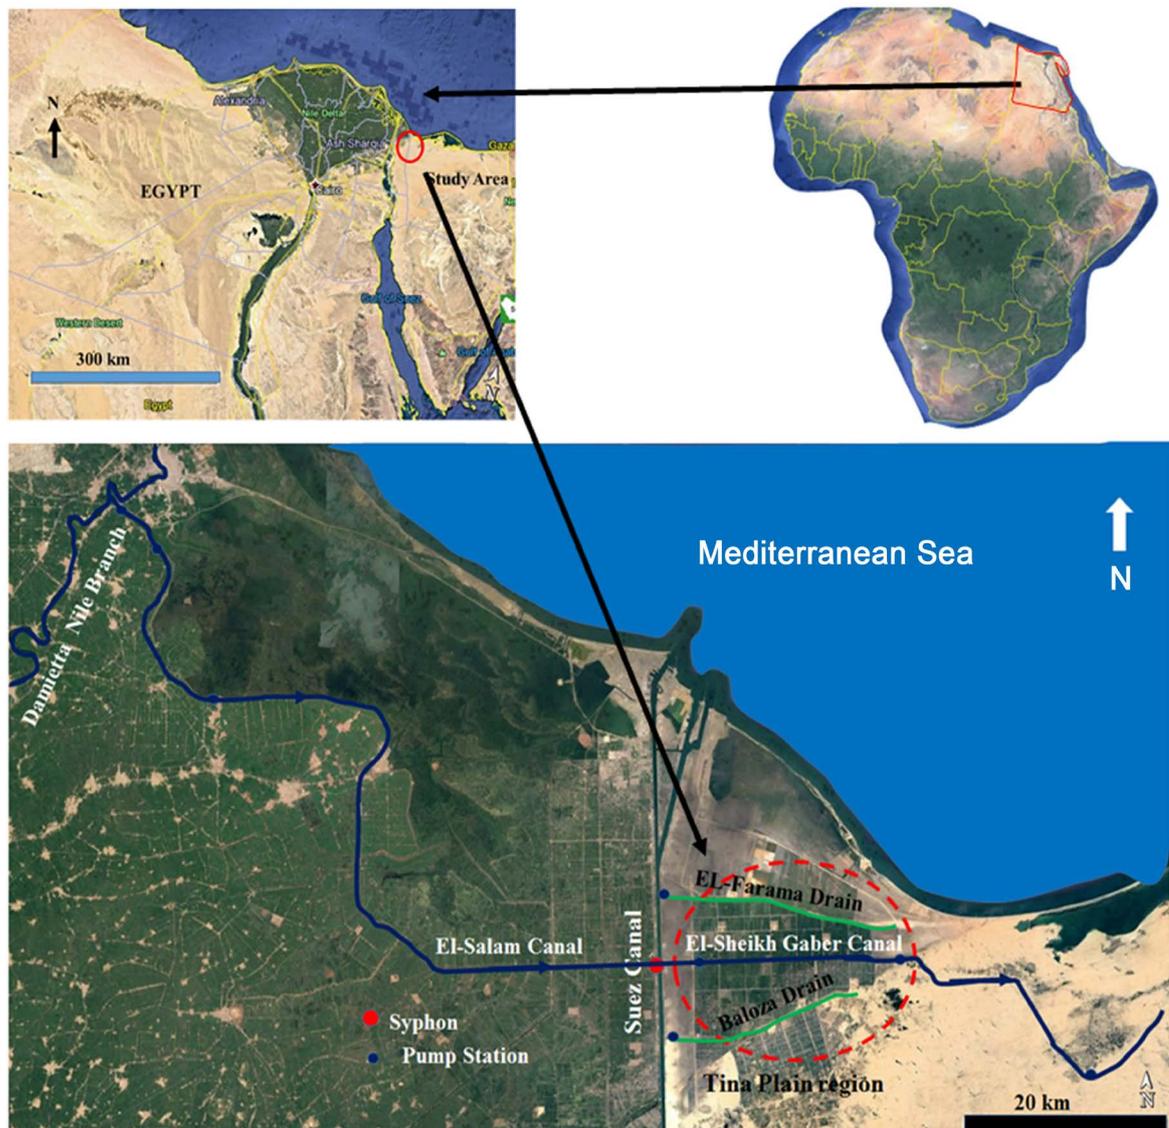
The study area is located in the north Sinai, Egypt, where the North Sinai Development Project (NSDP) to reclaim and cultivate 168,000 hectares. The surface drains Baloza and EL-Farama are bounded the cultivated Tina Plain region (21,000 hectares) from south and north respectively (**Figure 1**). The Tina Plain region is a part of the Nile Delta, it is characterized by being flat topography with mean elevations of 1.0 m above mean sea level, and the predominate soil is clay [21]. The irrigation and drainage networks were operated and managed by the North Sinai Sector for Water Resources and Infrastructures (SWRI), Ministry of Water Resources and Irrigation (MWRI) since 1998. El-Sheikh Gaber Channel is the main irrigation channel in the NSDP, its discharge is $160 \text{ m}^3/\text{sec}$, and the irrigation water resources are fresh Nile water blended with agricultural drainage water in a ratio of 1:1 with a maximum salinity of 1000 ppm. The famous cultivated crops are wheat, sugar beet, bean, potatoes, tomatoes, besides vegetables and poplar trees. The climate of the region is semi-arid, characterized by two main seasons, a dry season from March to November and a rainy season in winter from December to February. The average annual precipitation ranges between 80 - 120 mm and annual temperature varies from 14.6°C the winter to 27°C in the summer. The average annual evaporation ranges from 100 - 120 mm. Baloza Drain serves an area of 23,100 hectares, the drain length is 17.480 km, bed width varying from 2.0 m at the entrance to 10 m at the outlet with water depths 1.22 m to 1.97 m respectively and the inside slope is 3:1. At the drain outlet, a pump station exists at 3.500 km, it pumps the drainage water into the Suez Canal through a carrier channel of 3.0 km length. EL-Farama Drain serves

Figure 1. Location of Baloza and El-Faram drains in Tina Plain.

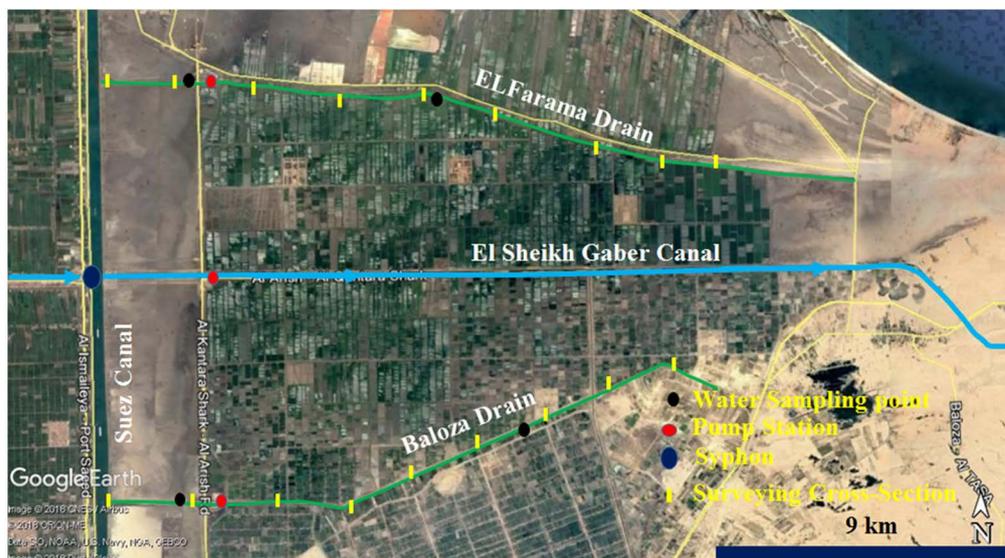
To examine the changes in the drain cross-section with respect to the designed cross-sections, groups of 18 cross-sections are distributed along the studied drains were selected according to, existing vegetation and existing hydraulic structures (Figure 2). The drains cross-sections were measured three times in one year, starting on August 2009, February 2010 and August 2010 using an echo sounder and total station survey devices. The actual cross-sections compare

Figure 2. Hydrographic survey cross-sections locations and water sample locations.

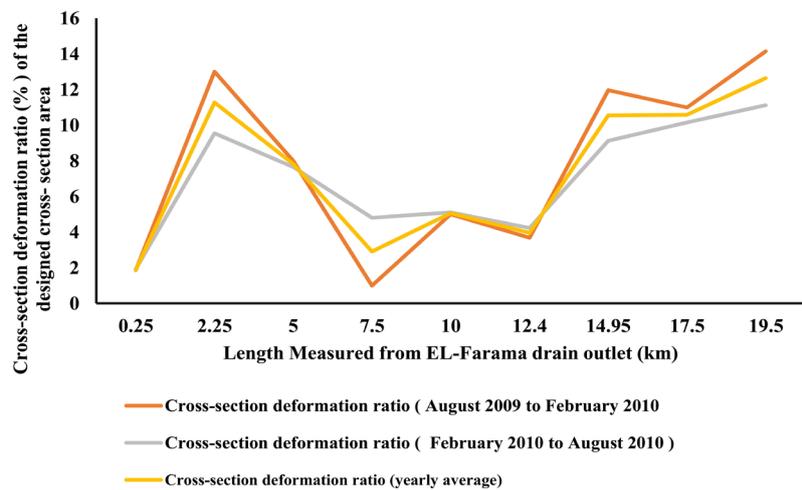
Table 1, summarizes the calculated average annual cross-section deformation as a ratio of the designed cross-section for the period from August 2009 to February 2010 and from February 2010 to 2010 August for the studied drains, it shows sedimentation in all measured cross-sections. **Figure 3** shows the cross-section deformation as a ratio of the designed cross-section area along EL-Farama drain path, the critical sedimentation reaches are from 0.250 km to 2.250 km and from 14.950 km to 19.50 km where, the reduction in the designed cross-section area ranges from 10.55% to 12.64% and 1.98 % to 11.8% respectively. The total calculated annual sedimentation in EL-Farama Drain is 34,369 m³. **Figure 4** shows the cross-section deformation as a ratio of the designed cross-section area along

Figure 3. EL-Farama Drain, calculated average annual cross-section deformation (sedimentation) as a ratio of the designed cross-section area.

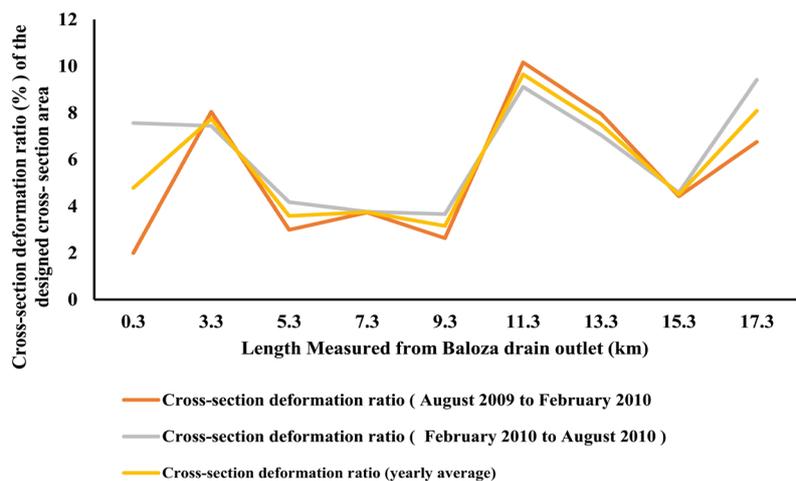
Baloza Drain path the critical sedimentation reaches are from 0.300 km to 3.300 km and from 11.300 km to 13.300 km, the reduction in the designed cross-section area ranges from 9.64% to 7.51% and 4.785 % to 7.74% respectively. The estimated total annual sedimentation is 29,153 m³. The increasing in sedimentation rates for the previous reaches are due to windblown during March month loaded with fine sands, coming from northern north west direction [21] [26]. The fallen sand inside watercourse reduces its cross section area, which so decreases storage capacity, constitutes a good environment for the growth of aquatic weeds, and effect on water quality, and reduces the hydraulic efficiency. Windbreakers of wooden trees (Casuarina and Equistifofia) of a matrix of one row can be used to reduce the fallen sand rates in the studied drains [21].

Figure 4. Baloza Drain, calculated average annual cross-section deformation (sedimentation) as a ratio of the designed cross-section area.
