Coastal Erosion in Yasawa Islands, Fiji

Keywords: Coastal Erosion, Currents, Jetties, Sea Cucumbers, Stable Sea Level, Fiji

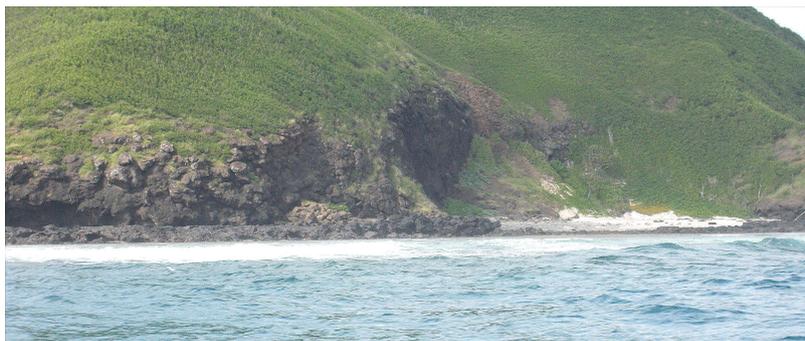
Figure 1. Typical shore segment from the Yasawa Islands. The high-tide level (HTL) is marked by a distinct rock-cut platform with undercut notches and sea caves, and a sharp notch on the sandy beach. This is indicative of coastal stability.

The predominant picture, however, is very strong coastal stability (**Figure 1**). The HTL is often associated with a distinct rock-cut platform, undercut notches and sea caves. Similarly, there are several coastal spits and barriers, which must have required multi-decadal time frames of formation. Leveling indicates unchanged conditions during the time of formation. Besides, we have found several examples of corals grown as “mini-atolls” because they are located only 40 - 60 cm below LTL placing a limit on their vertical growth.

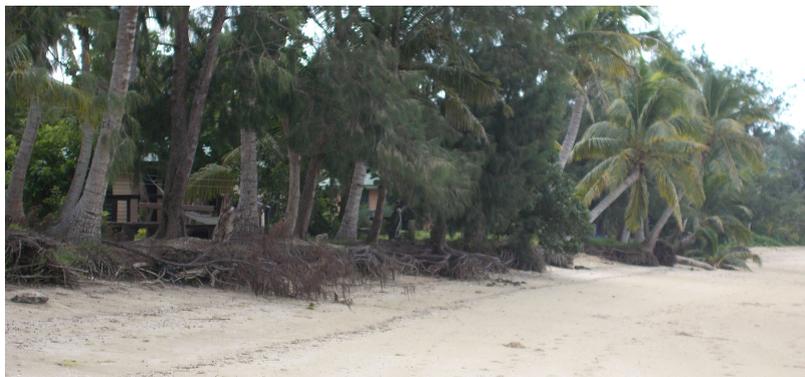
On the Island of Matakawa Levu, there is a resort known as Long Sandy Beach. Here, there is a segment of the beach that suffers erosion (Figure 2). In this case, we know exactly what had happened; extensive jetties (Figure 3) were built, which altered the coastal currents leading to erosion over a limited area of the beach (Figure 2).

Figure 2. Erosion at Long Sandy Beach due to redirected coastal currents. The redirection of currents was caused by the error of building a jetty. The photo was taken at low tide, with the HTL visible as a dark line on the beach.

the longshore transport seems to have stopped (**Figure 4(b)**). In the image from 2016 (**Figure 4(c)**), a reversal of the original coastal current transport is recorded. Now there is a strong transport to the west. Obviously this change in coastal current direction and motion of sediments is linked to a gyre in the current, turning to the beach, where it caused coastal erosion (**Figure 2**) over a distance of a few tens of meters; *i.e.* just where the current hit the shore.

This implies that it was the installation of jetties, which was the ultimate cause of erosion at Long Sandy Beach. That, in turn, implies that it was human error that generated the erosion. To blame “sea level rise” (which we heard some of the locals involved in the jetty installation say), is simply incorrect.

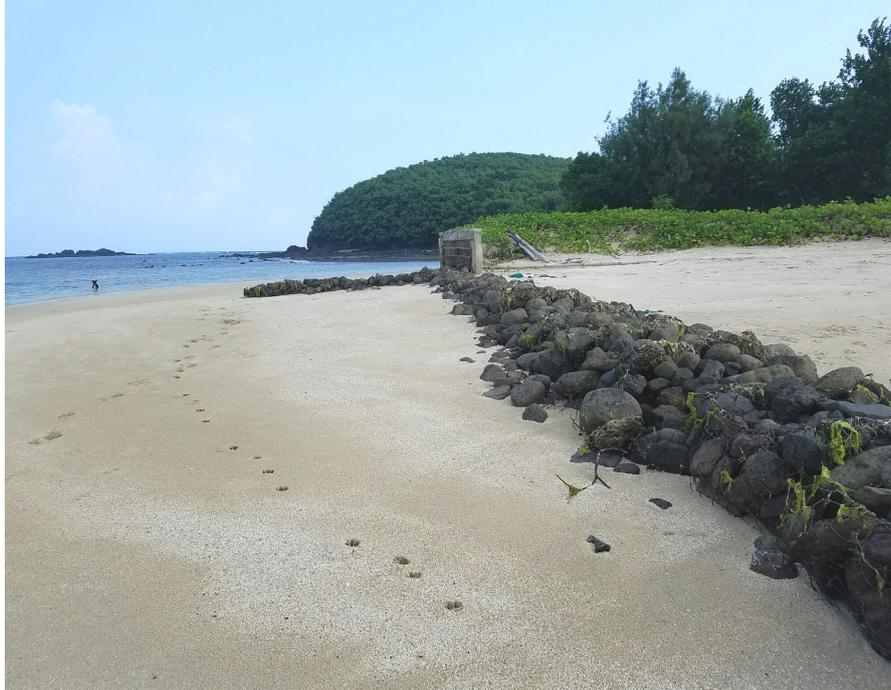
Figure 3. Jetties were built in order to extend the resort area. This blocked the existing coastal longshore-drift and current direction, which led to a reversed circulation with a gyre hitting the shore just where the erosion (**Figure 2**) occurred. Photo taken at low tide.

The main jetty cutting the original longshore-drift, and altering the currents (**Figure 3**) should be removed.

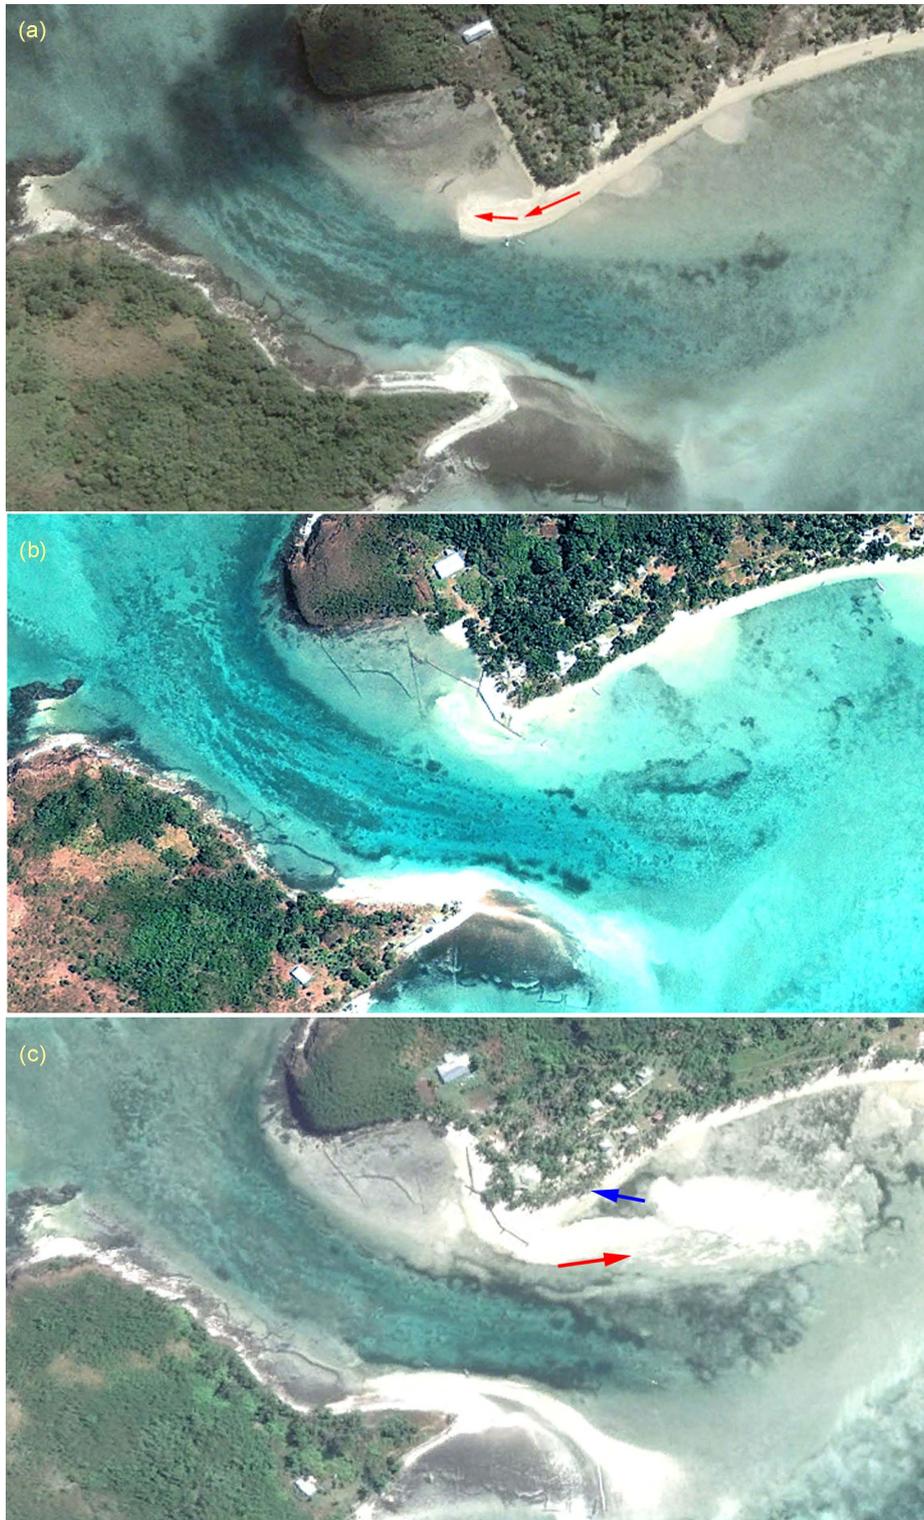
We can follow the changes from the succession of Google Earth images (Figure 4). In 2005, the coastal longshore-drift moved the sand eastwards (Figure 4(a)). In 2009, the jetties had been installed, and

Figure 4. Cartoon of Google Earth images: from 2005 (a), 2009 (b) and 2016 (c). In 2005, the shore was built out to the north-east. In 2009, the jetties had been installed, and the coastal transport was interrupted. In 2016, the coastal current is reversed to the north-west, and a gyre of the current hits the shore and causes local erosion.

The coastal erosion at Long Sandy Beach was initiated by the building of jetties, which generated a reversal of the coastal current and direction of sand transport (**Figure 4**). A gyre of the current became directed straight on-shore. This led to local erosion.

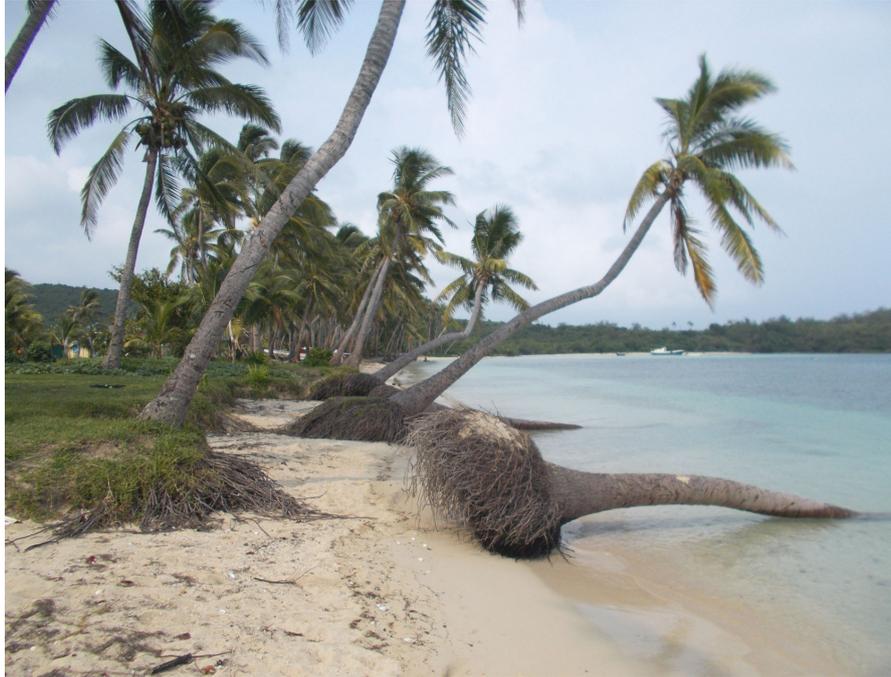
The erosion along the shore of Yageta Village is quite severe as shown in **Figure 5**. It started some years ago without any connection to any special events like a cyclone, an extreme storm or a tsunami.

Figure 5. Erosion and beach damage along the shore of Yageta Village. The sand removed was transported north-eastwards and formed a huge accumulation where the boat is in the background.

shore of Yageta Village was the ultimate cause of the change in sedimentary conditions, causing erosion along the village beach (**Figure 5**) and giving rise to vast accumulation of sand to the northeast (**Figure 6**) [3].

At Yageta Village quite severe erosion (**Figure 5**) and re-deposition of sand (**Figure 6**) occurred. It seems that this was initiated by the removal of “thousands and thousands of sea cucumbers” affecting the stability of the sand off the beach of the village.

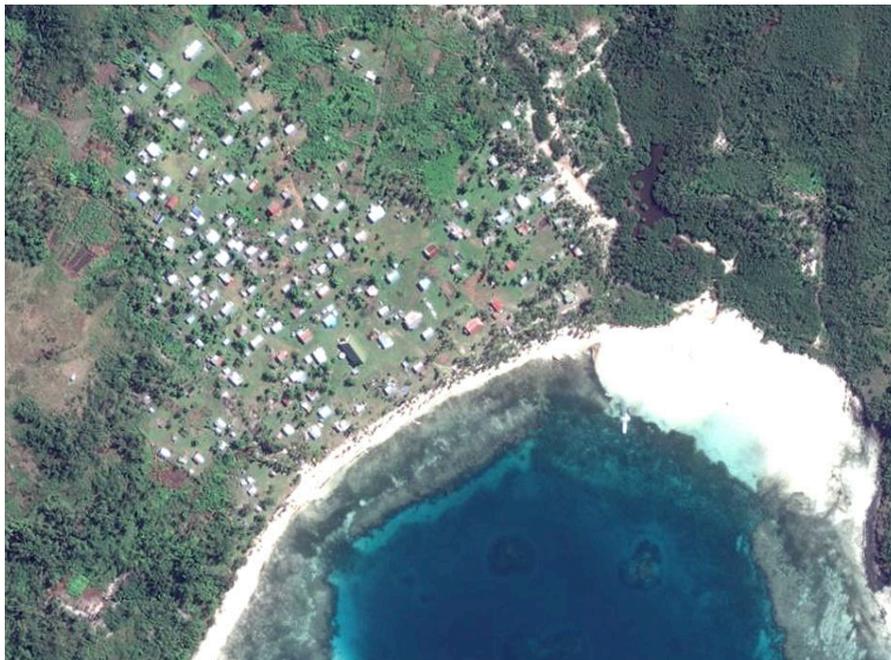
Figure 6. The sand eroded and removed from the village beach was deposited in a huge accumulation in the embayment to the northeast.
