# Installation of a Riparian Forest by Means of Soil Bio Engineering Techniques—Monitoring Results from a River Restoration Work in Southern Brazil

Soil bioengineering has been applied more and more in different regions of Brazil in recent years. The study in hand presents the installation of “new” riparian forest based on soil bioengineering techniques. This riverbank restoration work was implemented in the year 2010 and two onsite vegetation surveys, one shortly after the construction, and one in 2013. Besides that, the structures of reinforcement work, and its effectiveness were evaluated. By means of the vegetation survey, the applied species were examined for their ability to establish the riverbank in an environmentally sustainable way. Most notably, the species *Calliandra brevipes* Benth. (Fabaceae, Mimosoideae), *Phyllanthus sellowianus* Müller Arg. (Euphorbiaceae), *Salix humboldtiana* Willd. (Salicaceae), *Bauhinia forficata* Link (Leguminosae), *Inga marginata* Willd. (Mimosoideae) and *Ateleia glazioviana* Baill. (Leguminosae, Papilionoideae) showed a good growth development. The proportion of spontaneous vegetation increased significantly, with *Pennisetum purpureum*

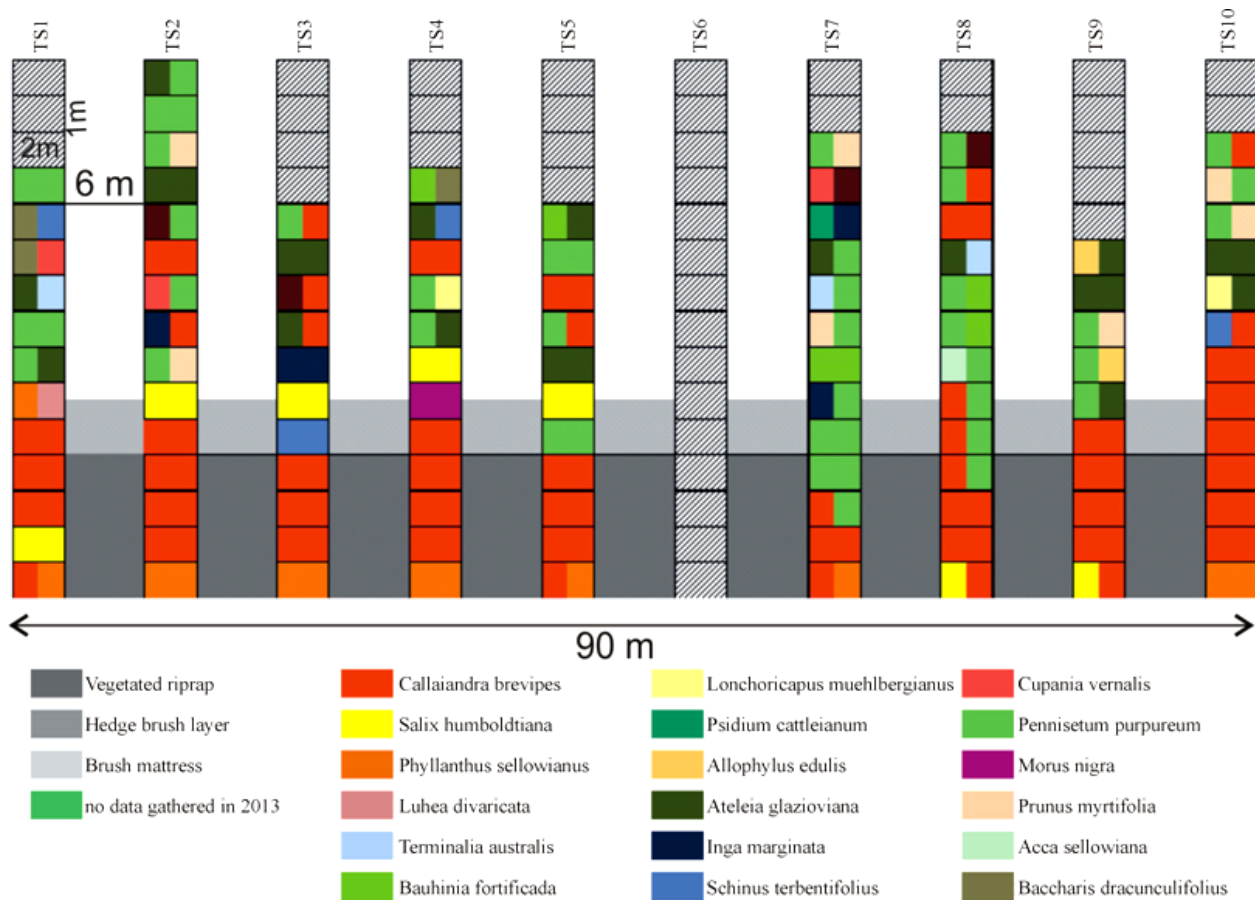
**Figure 4.**  
Sectional view, illustrating the interventions taken at the embankment.

The vegetation surveys were conducted in 2010 and 2013 as described in the methodology chapter. Figure 4 shows an overview of all sections.

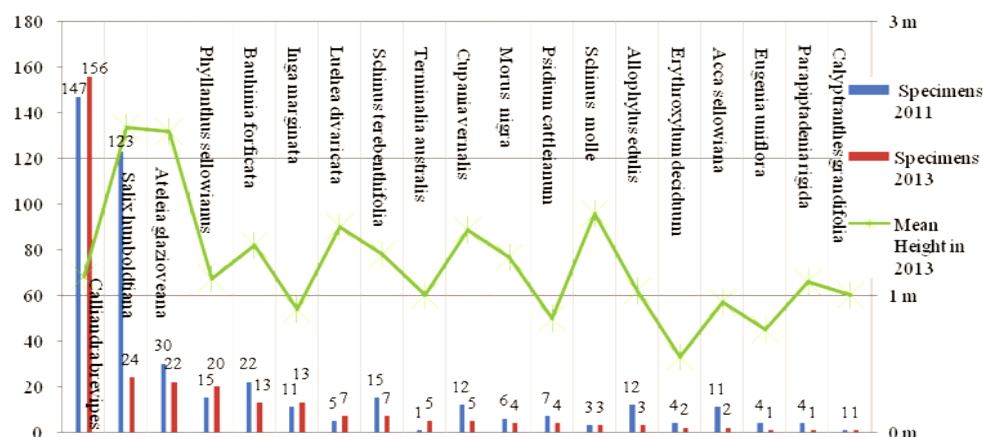
**Figure 5.**  
Growth development of the species after 3 years of intervention.

In Table 2, the species, which were found in the plant survey in 2011 but disappeared until 2013, are listed. Particularly strong losses were seen with the species *Machaerium paraguayense* Hassl., *Eugenia myrcianthes* Nied. and *Myrcianthes pungens* Berg. Legr. In Figure 5, the species, which were found in both vegetation surveys plus their mean plant height are shown. The species which developed best are *Calliandra brevipes*, *Phyllanthus sellowianus*, *Ateleia glazioviana*, *Salix humboldtiana*, *Bauhinia forficata* Link and *Inga marginata* Willd. In Figure 6, the growth development of these species is illustrated. *Salix humboldtiana*, showed great losses in the number of individuals. However, it grew very strong and highest of all species in the plant stand. The second highest grown species is *Ateleia glazioviana*. Its mean vitality was classified as 1 and only a few losses of plant individuals occurred. During the period of the monitoring, the plant individuals of *Phyllanthus sellowianus* increased and showed significantly the best growth along the mean water level. The plant individuals of *Bauhinia forficata* showed a good development. The same applies to *Inga marginata*, which could even increase the number of plant individuals. As well, *Luehea divaricata* Mart. and *Inga marginata* showed to be able to emerge on river embankments, as its number of individuals increased. *Pouteria salicifolia*, which was used in the hedge brush layer completely disappeared. Further species of the hedge brush layer are *Morus nigra* and *Terminalia australis*.
