Inspection and Assessment of Highway Bridges in Jordan along the Desert Highway: A Case Study

Hamadallah Al-Baijat, Mohammad Alhawamdeh

2.1. Al-Qadisia Bridge (Pre-Stressed and Reinforced Concrete Bridge)

2.2. Unayza-Petra Bridge (Reinforced Concrete Bridge)

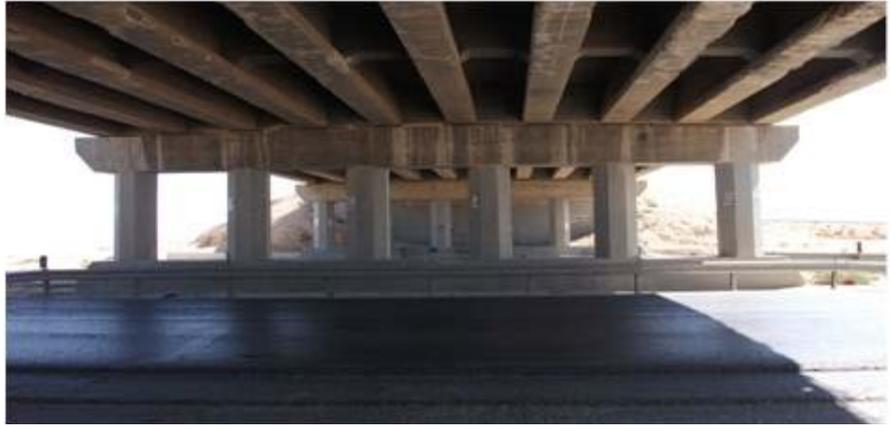
Figure 1. Al-Qadisia Bridge (Looking West; 10 Pre-stressed girders setting on three Intermediate Piers with six columns, and two Outside Abutments. Traffic S-N to Amman East Bay, and N-S to Aqaba West Bay).

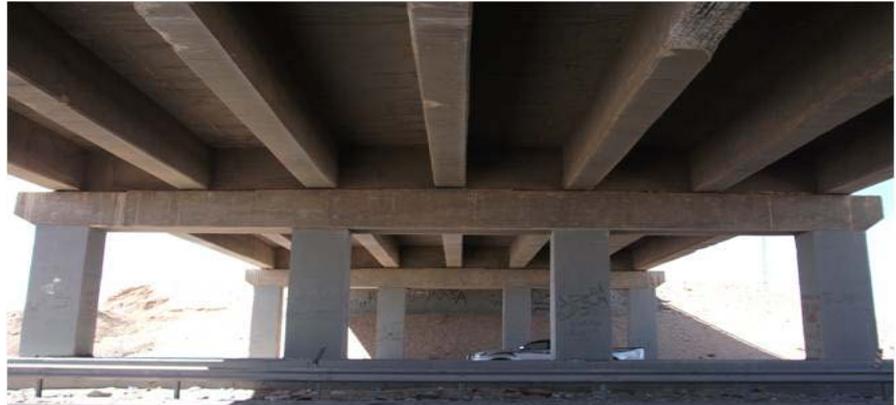
Figure 10. Unayza-Petra Bridge (Looking west; 7 reinforced concrete rectangular-beam girders setting on three Intermediate Piers with four 0.9×0.9 m columns, and two Outside Abutments. Traffic S-N to Amman East Bay, and N-S to Aqaba West Bay).
