A Study on the Cause Analysis for the Wall Thinning and Leakage in Small Bore Piping Downstream of Orifice

Kyeong Mo Hwang, Chan Kyo Lee, Cheong Ryul Choi
Power Engineering Research Institute, KEPCO-E&C, Yongin, South Korea
Email: hkm@kepco-enc.com

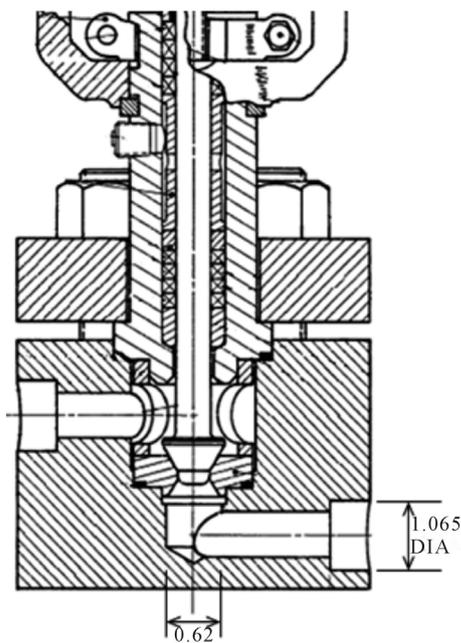
Figure 4. Valve configuration.

A valve, an orifice, and downstream part of the orifice are considered for the numerical analysis. **Figure 4** shows the valve configuration. A control valve, placed in front of the orifice, is modeled as simplified feature with incoming flow from the top side for the analysis. **Figure 5** shows the configuration of the analysis model. 5.5D

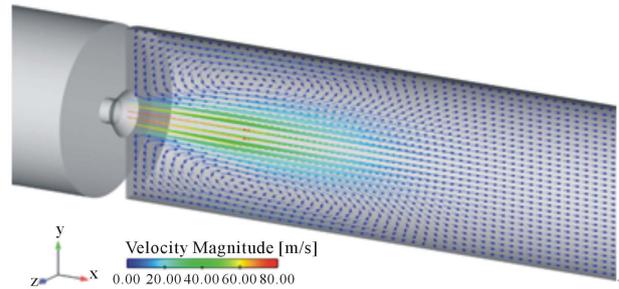
Figure 9. Steam velocity vector of size 1 μm .

rior is entrained to steam flow. For droplet size of 20 μm , droplet behavior is somewhat independent with steam flow.
