Regulation of Brahmaputra-Jamuna River around Jamuna Bridge Site, Bangladesh: Geoenvironmental Impacts

This study is conducted to evaluate the ongoing geoenvironmental impacts of Brahmaputra-Jamuna (BJ) River around the Jamuna Bridge (JB) site which was modified prior to the construction of Jamuna Bridge in 1996. Remote sensing and GIS techniques are adopted to evaluate the temporal and spatial geohazards. This study shows that the intensity of channel shifting has been increased due to regulation of river width at Siraganj–Bhuiyapur section from 11 km to 4.8 km. Planform analysis shows that the major channel has been stressed to migrate (315 m/year) eastwards. The phenomena of channel changes are predicted to be the consequences of interaction of water flow, sedimentation and channel corridor. The erosion and deposition have complicated variations over time and space due to the abrupt changes of flow and sedimentation around the regulated section. Due to width reduction, the bridge site in the braided system acts as sluice gate which can not accommodate the entire flow to release downstream properly. The helical flow developed with the interaction of guide bund creates local scou

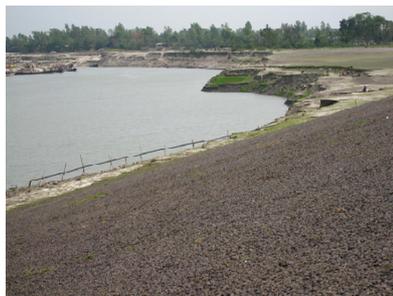
(a) Erosional point at Bhuiyapur (bend scour developed around the bridge abutment).

Figure 7. Erosional hazard and sediment characteristics of the bank materials.

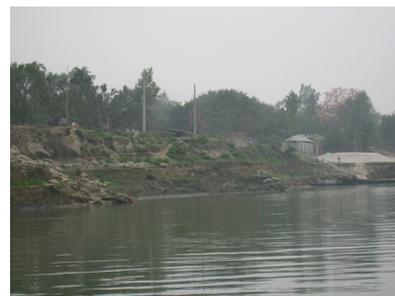
(b) Erosional point at Sirajganj (bank sliding occurred for downcutting of river bed).

(Figure 5). The field observation along Sirajganj site shows that the existing bank line is now eroding the previous floodplain (Figure 6), which is mostly composed of silty clay to clayey materials (Figures 7 and 8).

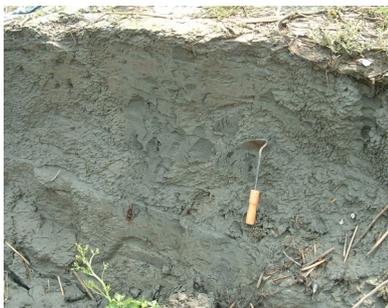
(c) Sediment signature in east bank, mostly composed of silt clay and mud.

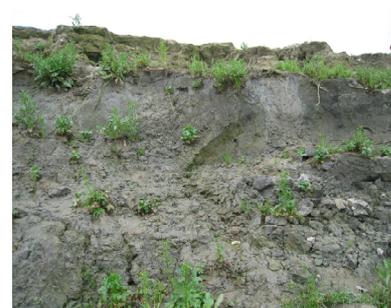
(d) Sediment signature in west bank, mostly composed of dark clay.
