Quasi-Static Flexural Properties of a Pultruded Glass Fiber/Unsaturated Polyester Square Pipe

Yuri Imai¹, Gabriel Fortin^{1*}, Badin Pinpathomrat¹, Keigo Nishitani¹, Anin Memon², Yuqiu Yang³, Akio Ohtani¹, Hiroyuki Hamada¹

This paper explores quasi-static flexural properties and fracture behavior of a pultruded glass fiber/unsaturated polyester square pipe for automotive structural applications. Three-point flexural testing is performed in an Instron Universal Testing Machine with steel jigs supporting the top and bottom surfaces of the pipe. Acoustic emission (AE) measurements are recorded during flexural testing to evaluate initial fracture in the pipe structure. After final fracture, five cross-sections of the pipe are cut at 50-mm intervals along the longitudinal axis, with the first cut located at the mid-span of the pipe. Cross-sections of a pipe from an interrupted test where initial fracture is detected from the AE method are also prepared. Damage locations and behavior on each cross-section are observed. The flexural testing results show that the cumulative AE counts increase rapidly from 2.5 kN, that final failure occurs at a maximum load of approximately 13 kN, and tha

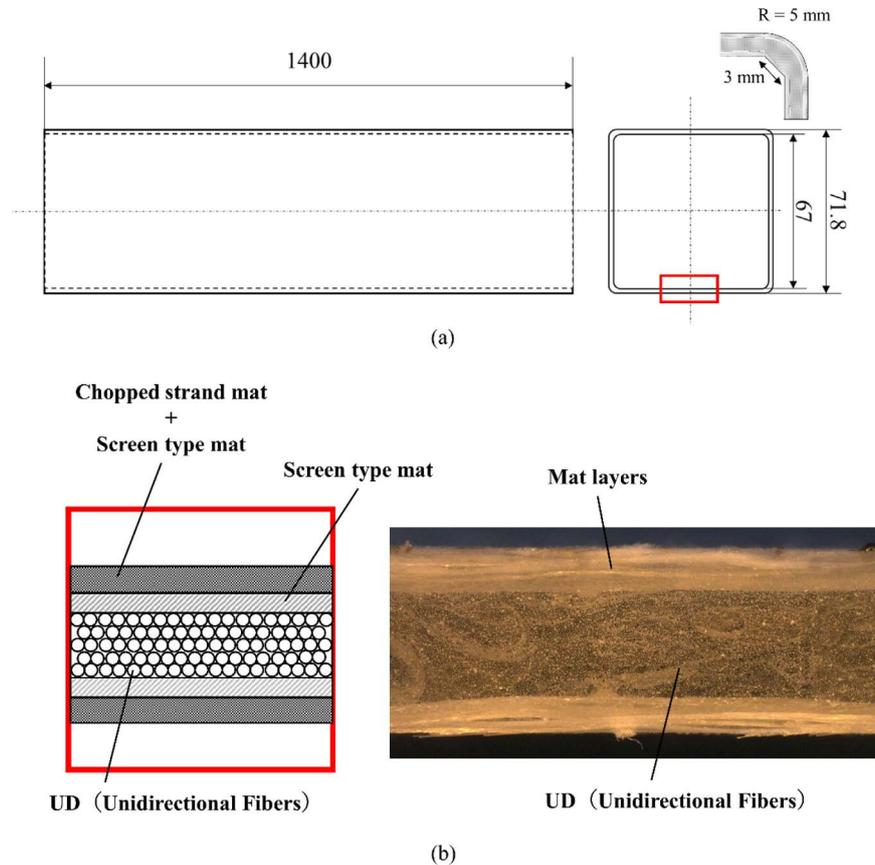
The pipes in this project are made from glass fiber-reinforced unsaturated polyester with a total length of 1400 mm, wall thickness of 2.4 mm. Details on the square pipe geometry with dimensions are presented in **Figure 1**. The outside corner radius is 5 mm, and because there is no inside corner radius, the length of the straight section at the inside corner is defined as 3 mm. As shown in the figure, the pipe walls are made of a laminated structure with the following 5 layers: a combination of a chopped strand mat and screen type mat on the two outside layers, followed by a screen type mat on the second layers, and unidirectional (UD) fibers oriented along the longitudinal axis of the pipe (0° direction) in the

Figure 1. (a) Square pipe geometry and dimensions (dimensions in mm); (b) Cross-section sketch and microscopy image of laminated structure.

inner-most layer. A sample image taken by optical microscopy of this laminated structure is also shown in **Figure 1**.

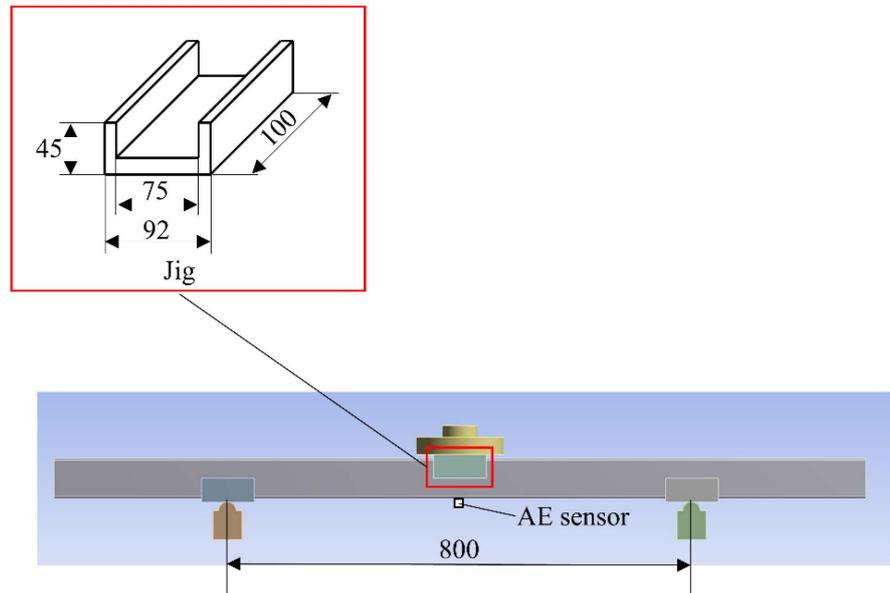
Quasi-static three-point bending tests were performed on the pipes in an Instron Universal Testing Machine type 55R4206 at room temperature with a 10-ton load cell. The cross-head speed of the test was set to 20 mm/min. The square pipe was positioned within three U-shaped steel jigs where loads were applied, and the span length for testing was set to 800 mm. Details on the jig dimensions and mounting positions on the pipe for flexural testing are presented in **Figure 2**. This U-shaped steel jig was developed to avoid compressive and buckling fracture just below the normal loading jig. At the mid-span of the pipe on the underside, corresponding to the tensile surface during flexural loading, an AE sensor (Nippon Physical Acoustics, Inc., micro-30) was positioned for recording data on crack propagation during testing. Load-displacement data and amplitudes generated from crack formation were measured. The threshold value for AE amplitude measurements was set to 55 dB to eliminate extraneous noise.

Figure 2. Jig mounting position of square pipe bending test (dimensions in mm).

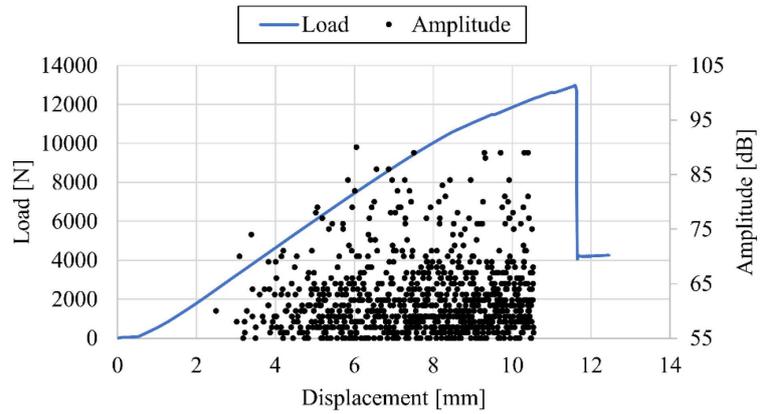
Flexural load-displacement data of the pipe with the recorded AE amplitude measurements are presented in **Figure 3**, as well as AE energy measurements and cumulative AE counts in **Figure 4** and **Figure 5**, respectively. The load-displacement curve shows that failure of the pipe occurs at approximately 13 kN, at a displacement of 11.6 mm. The data shows linear behavior until a

Figure 3. Relationship between square pipe bending test and AE amplitude.

displacement of 6 mm, after which point it transitions to non-linear behavior followed by final fracture. Figure 3 shows that the recorded maximum amplitude values increase with increasing load, up to a value of 90 dB first reached at 6 mm of displacement, with a larger number of amplitude events being more concentrated in the range of 55 - 70 dB throughout testing. Figure 4 shows a clear trend in increasing acoustic energy values with increasing displacement as well.

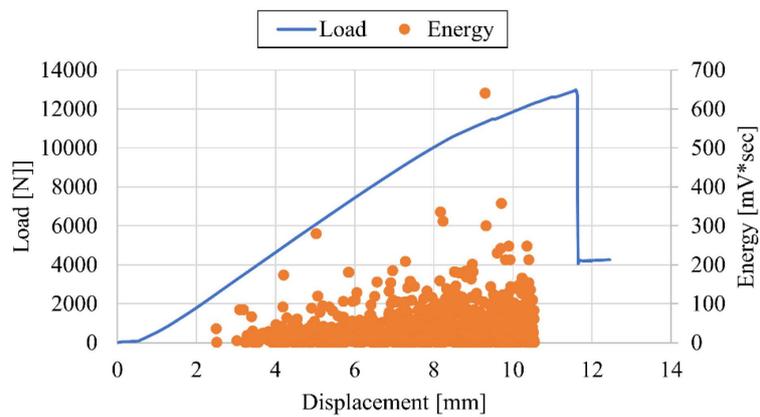
Figure 4. Relationship between square pipe bending test and AE energy.

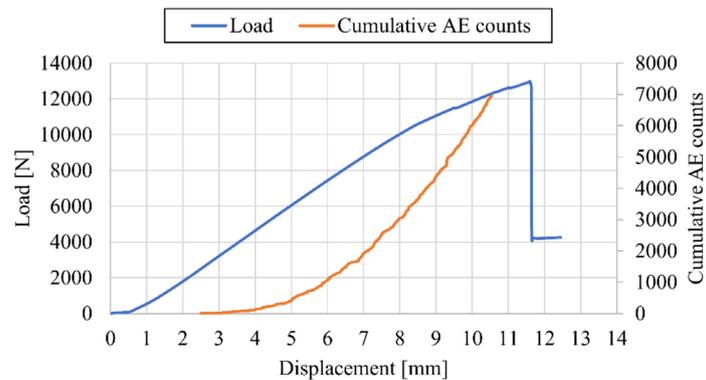
Figure 5. Relationship between square pipe bending test and cumulative AE counts.

From **Figure 5**, it is very clear that the cumulative AE counts number rapidly increases from approximately 2.5 kN. This corresponding load value will be used as the load limit of the interrupted test for observations of initial fracture in the following section.

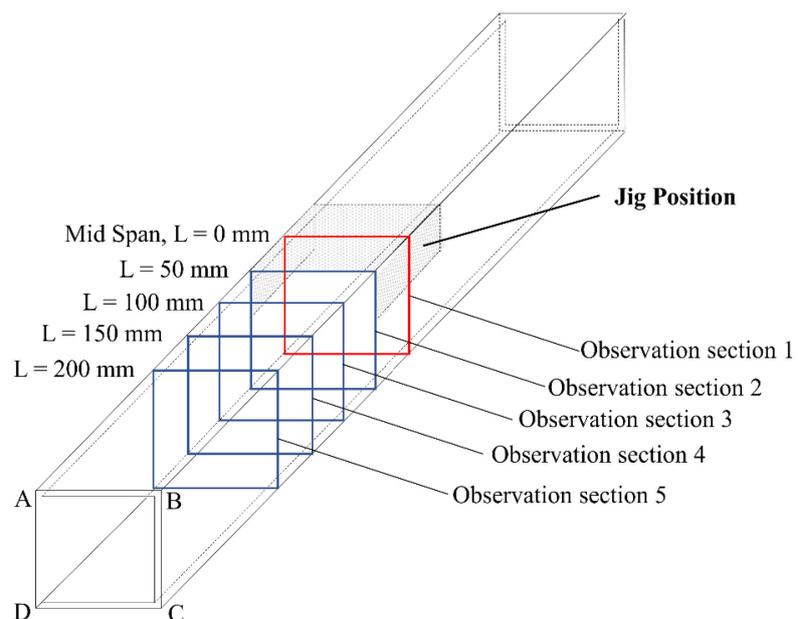
A sketch showing the locations where cross-section cuts were made for observation of the pipe after final fracture is presented in **Figure 6**. The jig position relative to the cuts is also indicated. The first cut was made at the mid-span of the pipe, at a reference position of $L = 0$ mm. The four corner sections along the pipe were also identified (A to D) as shown in the figure. The cross-sections revealed that failure was only present in the regions of corners A and B, located on the compressive side of flexural loading. Therefore, optical microscopy images of corners A and B for all five sections are presented in **Figures 7(a)-(e)**. Fracture regions are indicated by red arrows or outlined with markers. Sketches of the corner regions and fracture locations are also presented as required. In **Figure 8**, examples of fiber wrinkling that were observed in all cross-sections at the two bottom corners (corners C and D) are shown. Fiber wrinkling was present in all sections, as a result of the manufacturing process in the as-received pipes.

Figure 6. Sketch showing location of square pipe cross-sectional observations and Orientation of corners A, B, C, and D along the pipe.

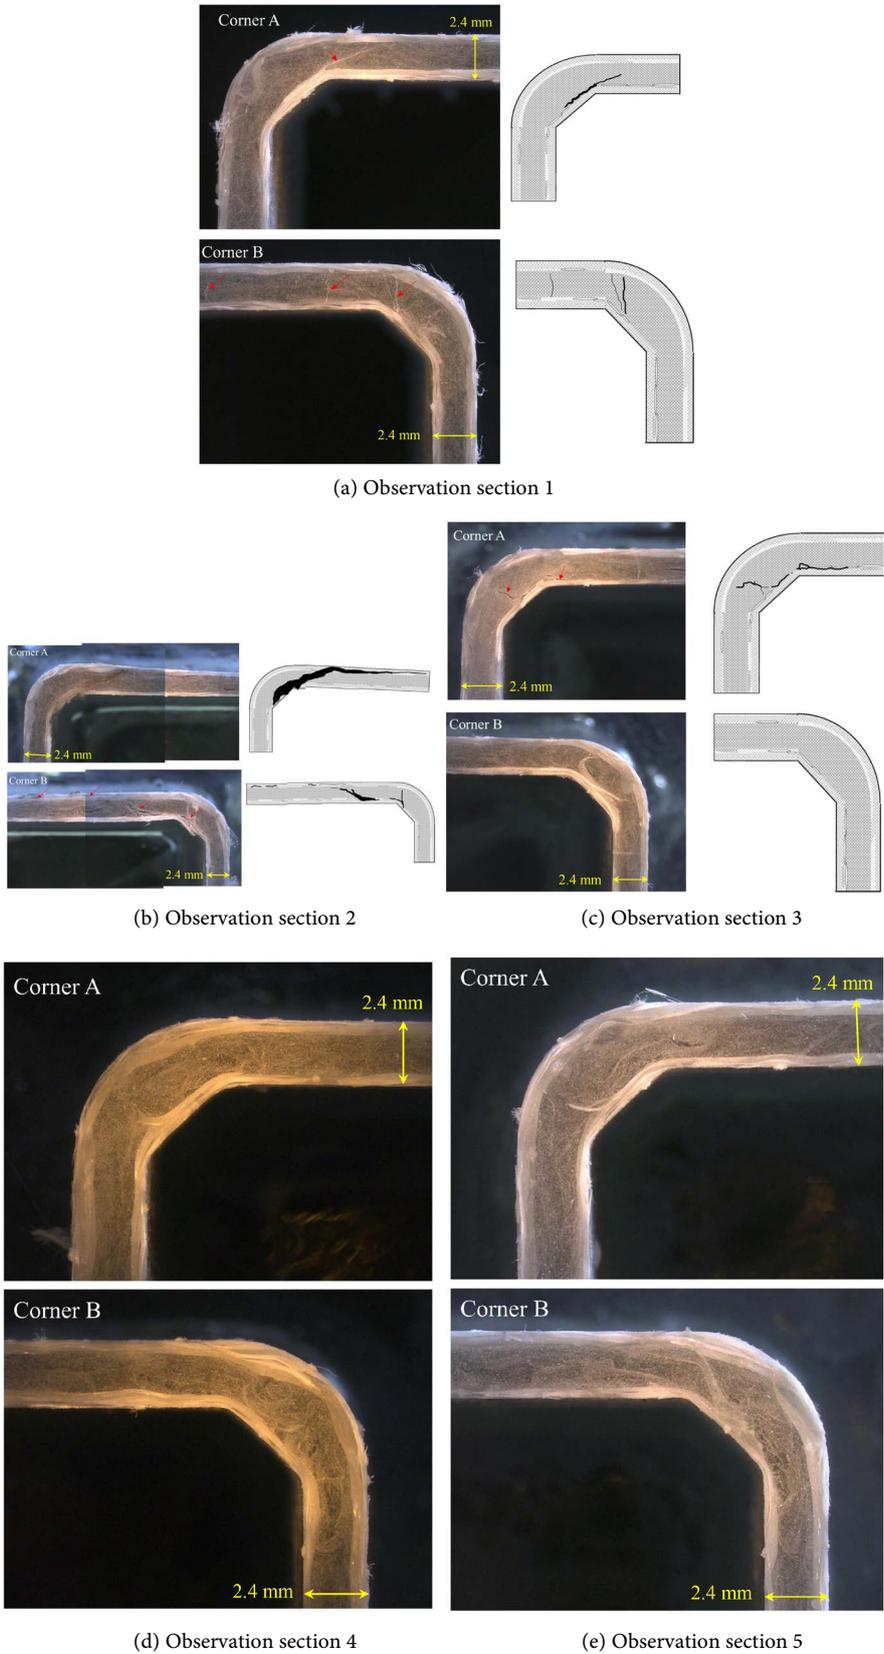
Signs of fracture in corners A and B are observed in Sections 1 to 3 (**Figures 7(a)-(c)**), while Sections 4 and 5 do not show any signs of fracture, meaning that fracture did not propagate this far along the pipe. The largest fractures are observed in section 2 (**Figure 7(b)**) located 50 mm from the mid-span of the pipe. As this section is located at the edge of the upper jig, it is likely that local stress concentrations were built up the most around this region.

Figure 7. Cross-section observation of square pipe after final failure during flexural testing.

The observed fractures in the cross-sections in **Figures 7(a)-(c)** are transverse cracks within the unidirectional layer of the laminate structure, due to fracture at the interface between the fibers and resin. In addition, interlaminar failure is observed where separation occurs between the inner unidirectional layer and the adjacent screen-type mat layer. This is clearly observed in **Figure 7(b)**, **Figure 7(c)**. It is likely that the transverse cracks initiated in the UD layer of the corners, and later propagated as interlaminar separation.

the observed deformations in cross-section 2 (**Figure 9**), and with the fracture observations of **Figure 7** and **Figure 10**, showing failure in the corner regions.

- Cross-sections 1, 2, and 3 of the pipe after final fracture located at mid-span, 50 mm, and 100 mm from mid-span, respectively, contained fractures in the corner regions. The most significant fractures were observed in Section 2, located at the edge of the steel jig on the top surface of the pipe. Maximum deformations of the pipe marked by downward bending of the top surface and inward bending of the upper corners are also observed at this cross-section. Initial fracture is also observed in the same corner regions from a pipe after interrupted testing, based on the AE results. Fracture clearly starts in the corners and propagates until final fracture.

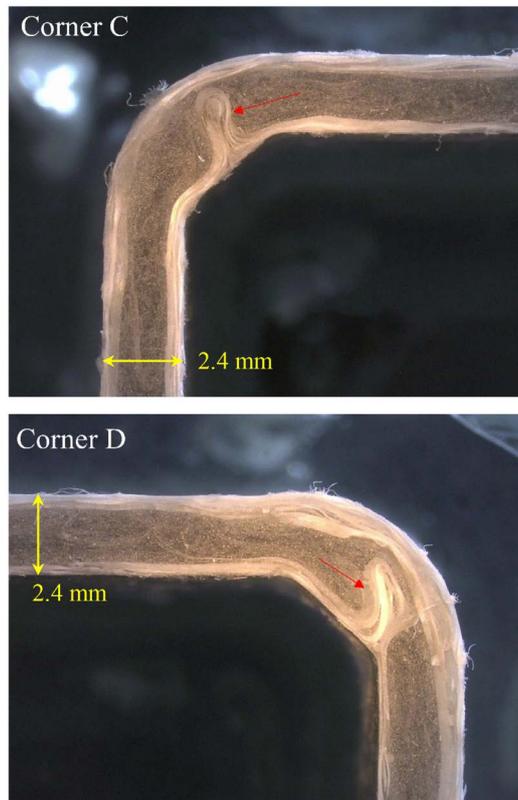
Figure 8. Corner wrinkling of fibers, as observed on corners C and D along the square pipe.

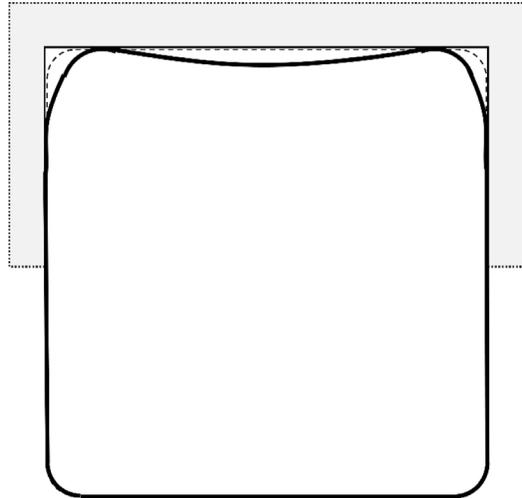
At cross-section 2, located at 50 mm from the mid-span of the pipe, directly under the edge of the upper steel jig, significant deformation is also observed on the two upper corners A and B as well as the upper surface. A cross-section schematic diagram of the deformation behavior at this section of the pipe is presented in **Figure 9**. The deformations are characterized by bending of the top surface downwards, as well as the top two corners being bent inwards. These deformations are observed because a moment acts on the corners due to the application of the load by the jig, causing the observed curvature in the upper flat section of the pipe and inward displacement of the corners.

Figure 9. Cross-section schematic diagram of deformation behavior on center section of square pipe.

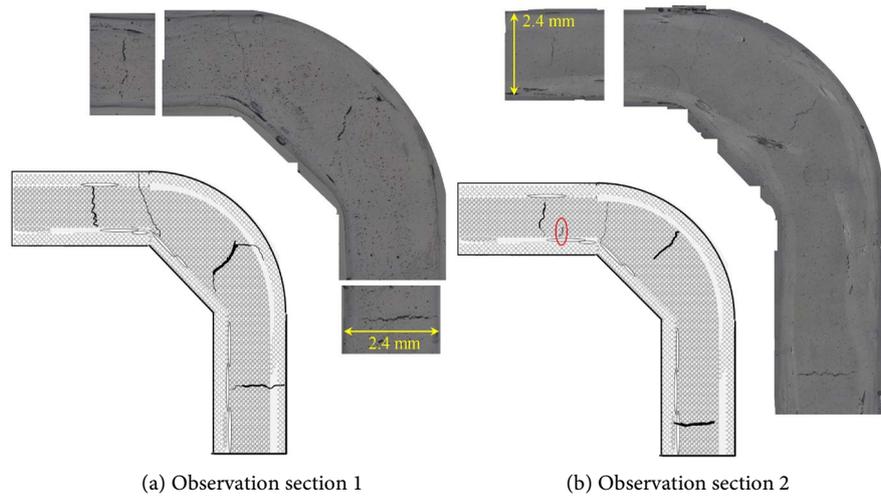
Cross-section microscopy images taken from a pipe after an interrupted bending test at the onset of rapid cumulative AE counts at Sections 1 and 2 are presented in **Figure 10**. In this pipe, signs of initial fracture can be observed in both sections, in the upper corner regions as in the pipe tested until final failure.

Figure 10. Cross-section observation of square pipe after interrupted flexural test.

It is very clear that cracks initiate in the corner regions, and the AE results correspond to crack growth in the corner regions of the pipe, until final fracture.

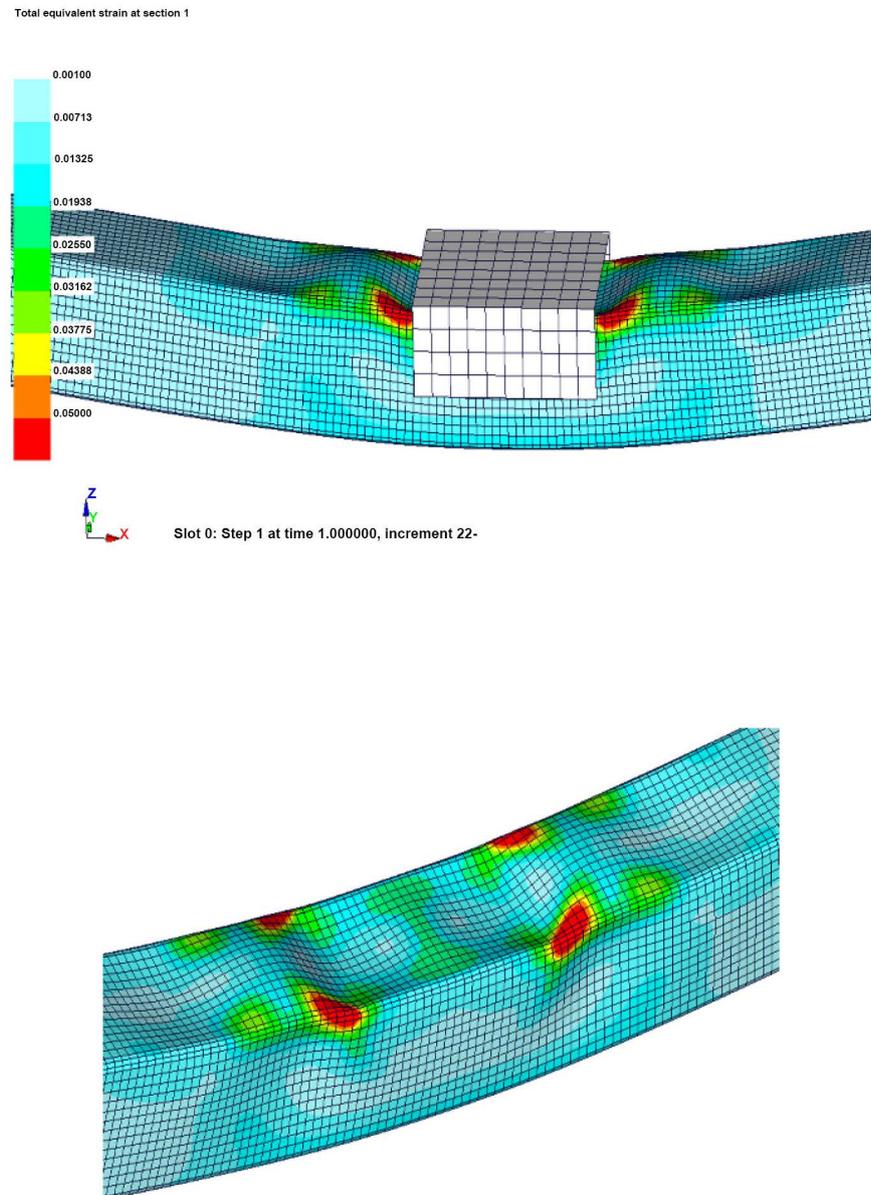
Finite element analysis results showing the deformation behavior of the square pipe during three-point flexural testing are presented in **Figure 11**. The simulation was performed in ABAQUS, and the model consisted of 17,009 nodes, 16,864 elements, and mesh size of 5 mm. As the purpose of this simulation was to study the fracture aspects and locations based on pipe geometry, the model consisted of a homogeneous material with the same dimensions as the physical pipe in this study. The maximum failure load of the simulated pipe was 21 kN.

The results show that maximum deformation occurs at the corners in contact with the jig. It can also be seen that the deformation of the pipe extends longitudinally along the two upper corners. These results are in good agreement with

Figure 11. Finite element analysis results of deformation behavior on square pipe.

- Finite element simulation results show that maximum deformations during testing occur at the upper corners of the pipe, at the edges of the upper jig. The deformations also extend along the longitudinal axis of the pipe at the corners. These results are in very good agreement with the observed fracture locations and deformations of the cross-section cuts.
